**REPORT OF POST CLEAN-UP VERIFICATION AND CERTIFICATION (PCVC) EXERCISE OF SPDC IMPACTED SITE ON 10" DIEBU CREEK-NUN RIVER PIPE LINE @ PEREMABIRI IN SAGBAMA L.G. AREA OF BAYELSA STATE.**

10" Diebu Creek – Nun River Pipe Line @ Peremabiri, Bayelsa State.

- INCIDENT NUMBERS: 2014\_1147733
- DATE OF SPILL: 25-03-2014
- COURSE OF SPILL: Equipment Failure
- MATERIAL SPILLED: Crude
- QUANTITY SPILLED: 106 Barrels
- QUANTITY RECOVERED: 80 Barrels
- AREA IMPACTED: 1.5502Ha
- DATE CLEAN-UP COMMENCED/DURATION: 25-03-2014 to 15-05-2015
- CLEAN-UP METHOD: Land Farming
- DATE OF PCI: 21-05-2015
- CONTRACTOR'S NAMES: DJ Global Resources
- SPILL POINT COORDINATES: N 04° 39' 40.9"  
E 006° 04' 43.0"

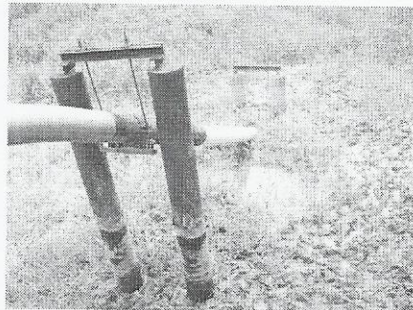
1. The PCI Site was at Peremabiri Flare/Flow Station (See Fig. 1a), overlapping Incident Number 2014\_1139648; about 3 Meters apart.

Fig. 1a Spill Point (3M Apart)

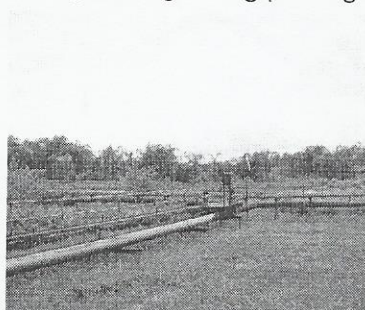
2. Most of the impacted Area was along the Swampy Terrain covered by thick Mangrove Vegetation. (See Fig. 1b). This posed difficulties for Soil Sampling during inspection.
3. Evidence of tiled or brought-in Soil was noticeable at Site around the Spill Point (See Fig. 2a)
4. The Soil was not wet with Oil but Silvery Sheens were noticed around the Spill Point (See Fig. 2b) even though SPDC Representatives claim that, it is iron – Lab results will tell.
5. No Oil stained Vegetation was observed, ONLY weathered Rafia Palms along the adjoining land to the impacted area. (See Fig. 2c)
6. The area covered by the Spill has grasses growing (See Fig. 1c)

Fig.1b Swamp & Impacted Area

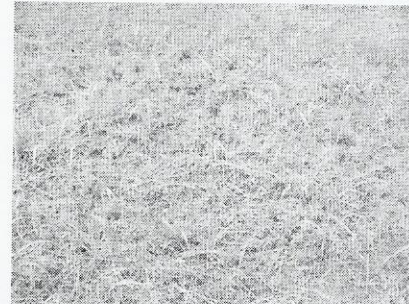
Fig. 1c Rejuvenation of Grasses

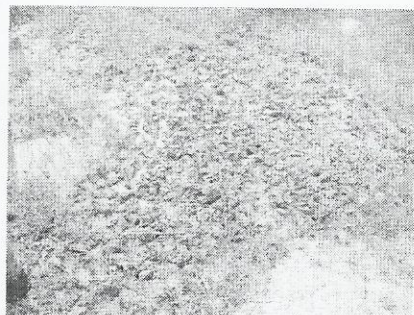
Fig. 2a Evidence of Tiled Soil

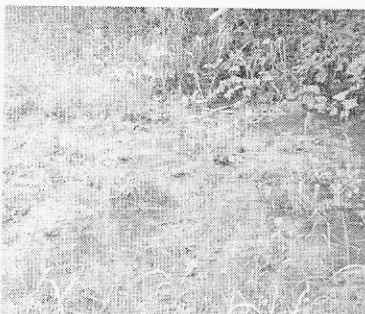
Fig.2b Silvery Sheen

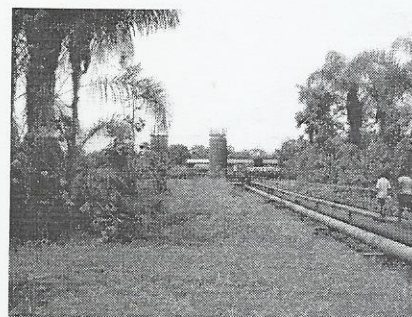
Fig. Weathered Rafia Palms
