NATIONAL OIL SPILL DETECTION AND RESPONSE AGENCY

## SOME PHOTOGRAPHS TAKEN DURING THE JOINT INVESTIGATION VISIT

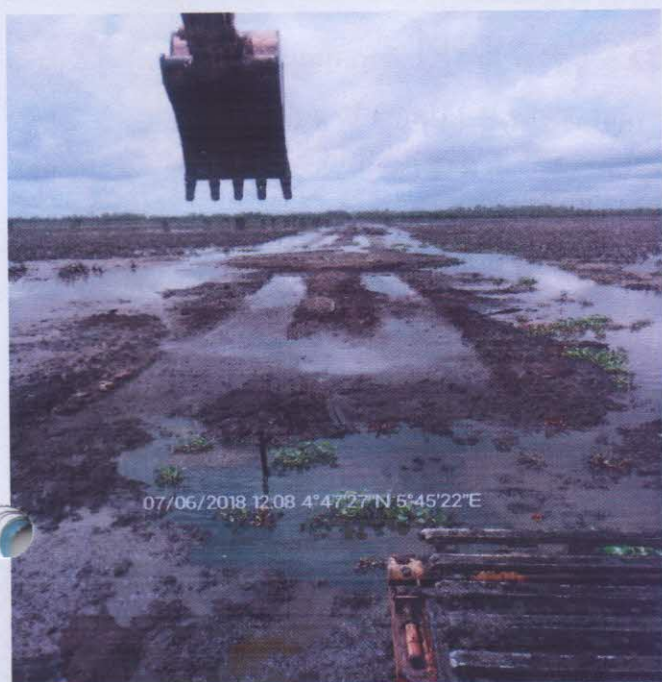
Fig A: Incident Area on arrival of the JIT

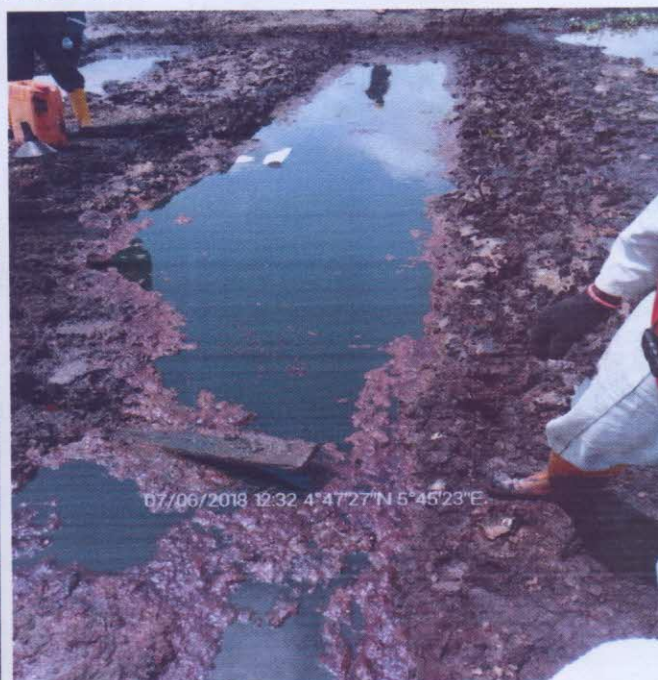
Fig B: Oil spill impacted area

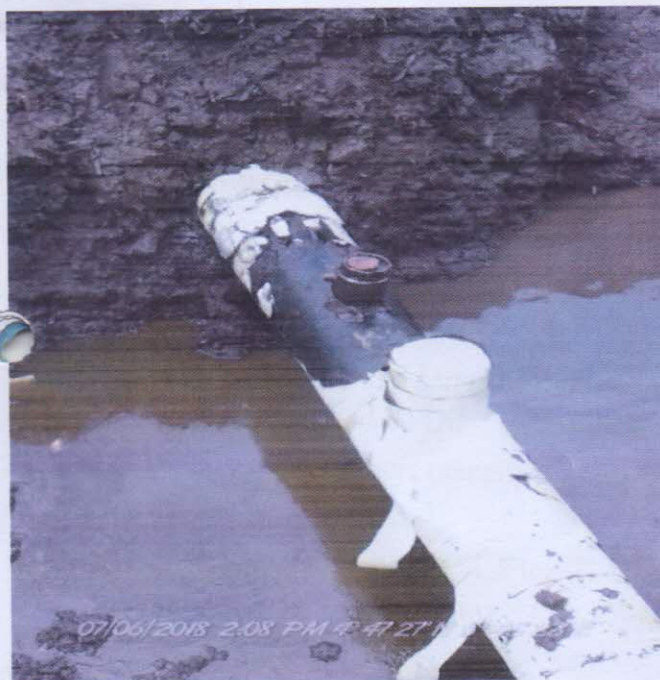
Fig C: Incident Facility after excavation
