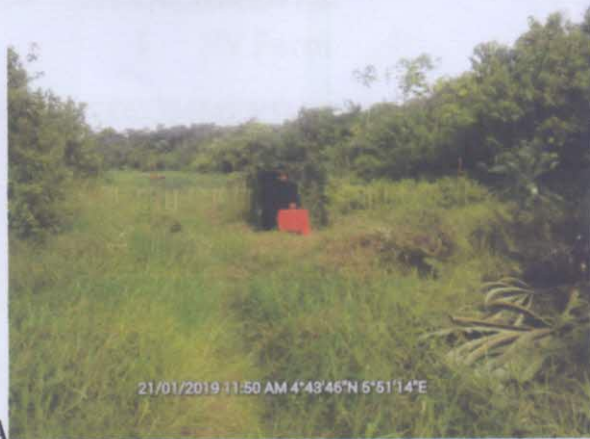
A

**FIG A: Site on arrival along right of way**

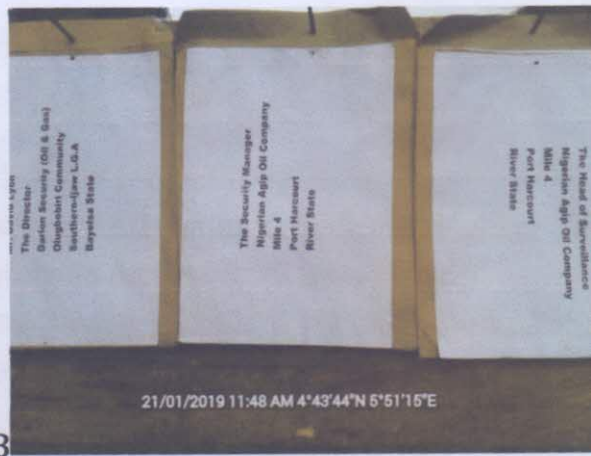
B

**FIG B: Letters pinned to a board along RO**

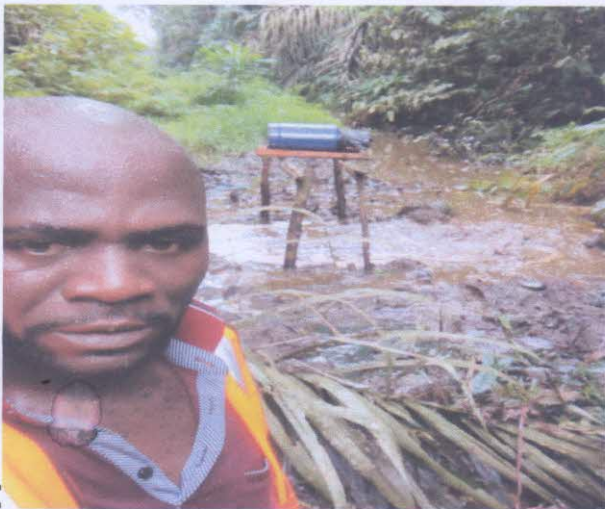
C

**FIG C: Incident point with IED**

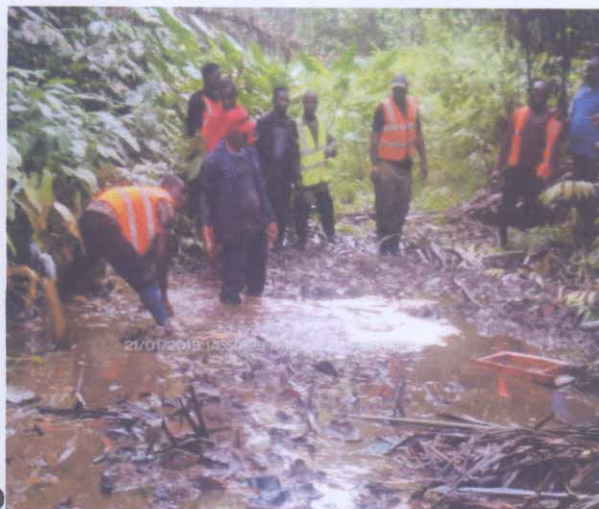
D

**FIG D: Oil and Gas scouring the site**

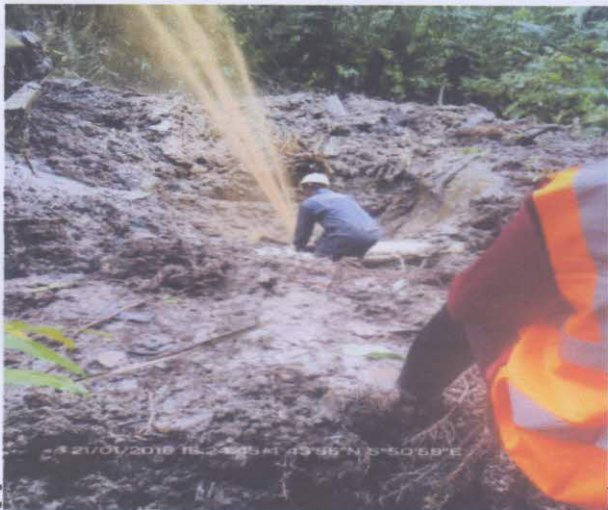
E

**FIG E: Incident point on exposure**

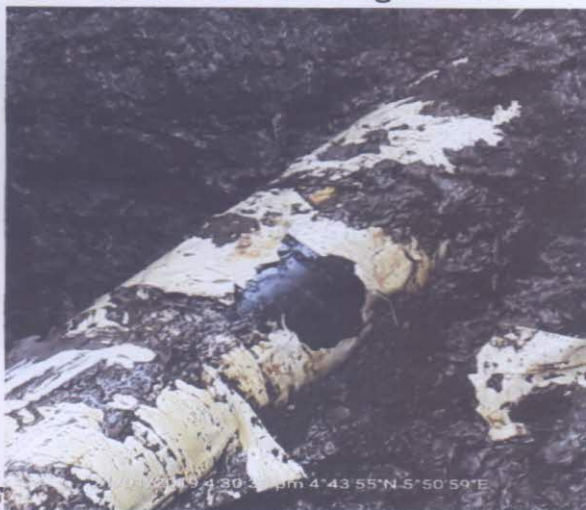
F

**FIG F: Incident point on full exposure**

ix. Repair work (patch welding) was concluded on January 22, 2018.
