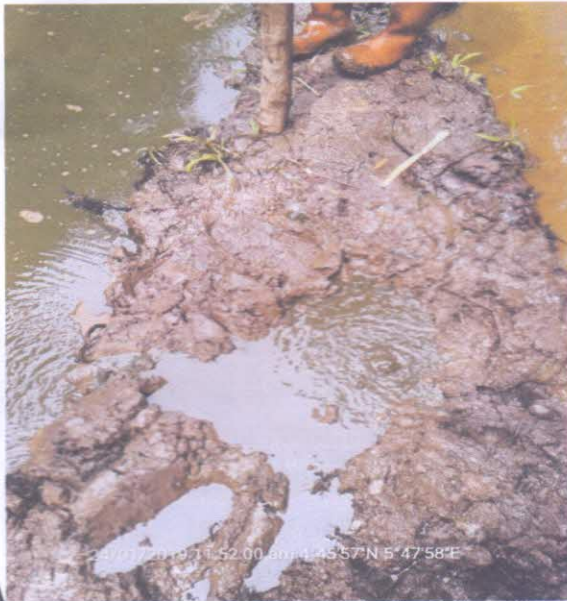
A

**FIG A: Incident point**

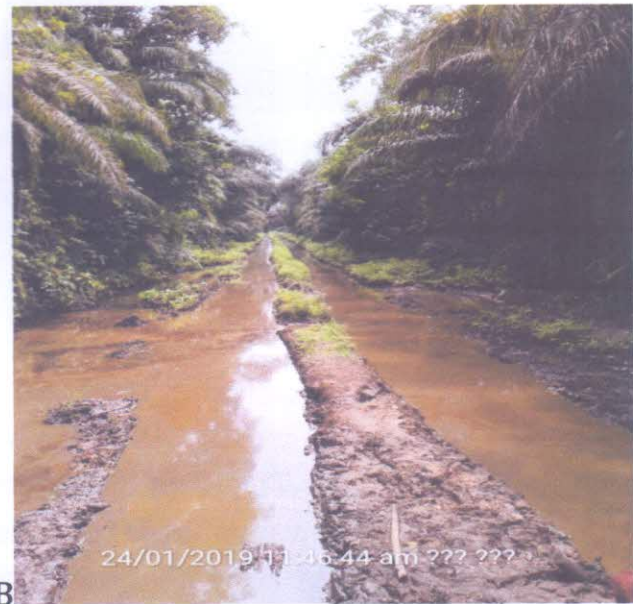
B

**FIG B: Environment of impact**

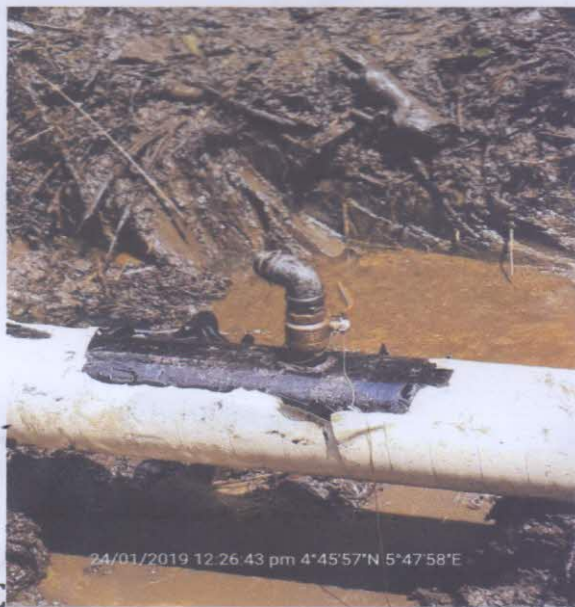
C

**FIG C: Incident point after exposure**

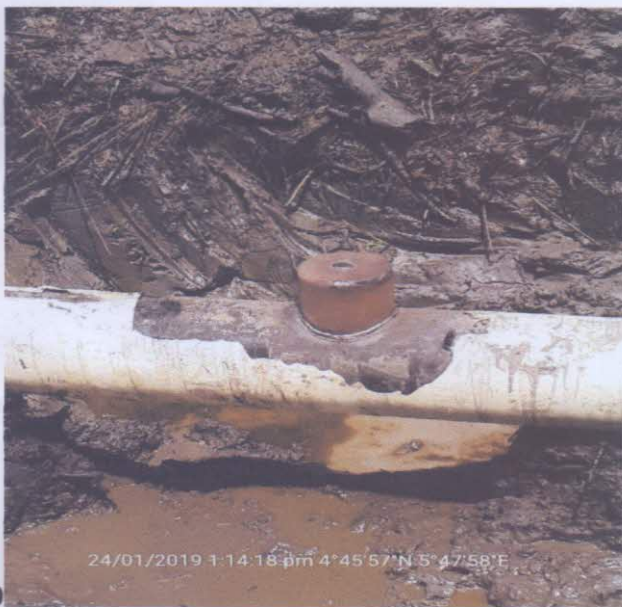
D

**FIG D: Incident point after repairs**

- i. On arrival at the site, the team saw some of the vandals along the pipeline right of way though at a little distance.
- ii. The military had to fire a couple of gunshots and combed the bush before the team could commence work which was a little scary.
- iii. Crude impact was mainly within the Company right of way, impacting an estimated 694 m<sup>2</sup>.
- iv. The spill was as a result of unknown persons installing a 2" valve on the pipeline at 12 O Clock position for oil theft.
- v. Repair work (coning) was concluded on January 24, 2018.
