## APPENDIX 1

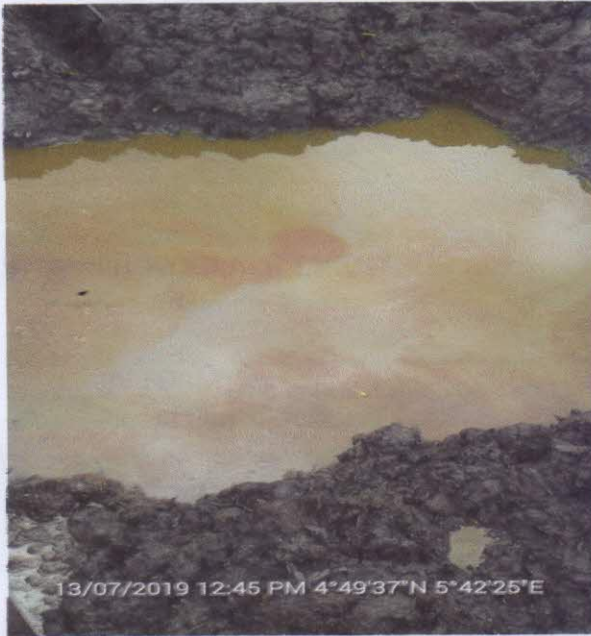
**SPILL POINT ON ARRIVAL.**
