**APPENDIX 1**

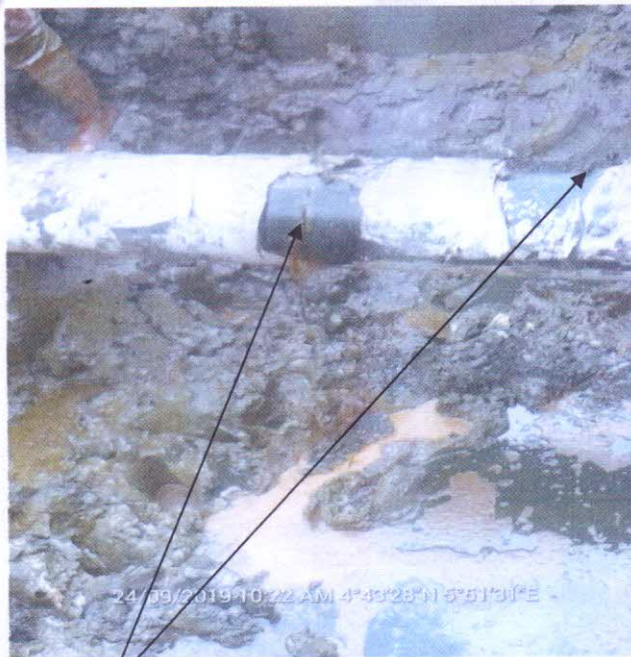
**SPILL POINT ON ARRIVAL.**
