## Appendix 1

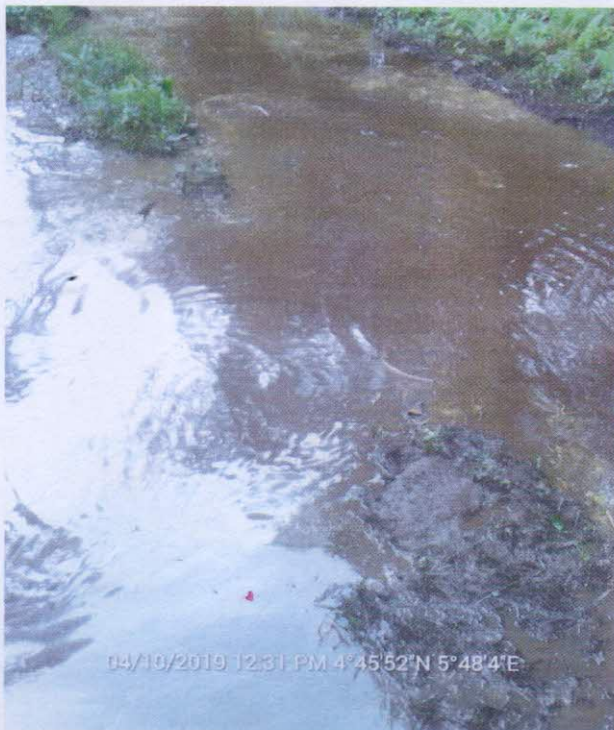
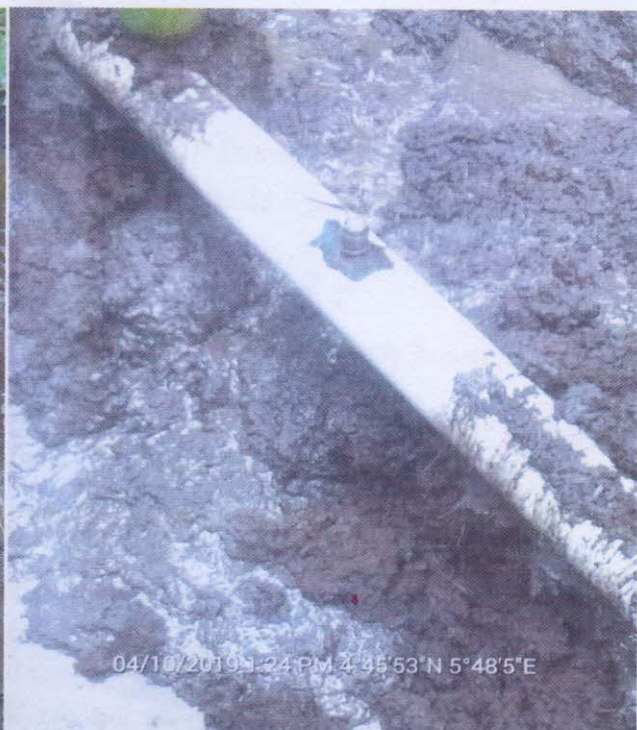
*The Valve was coned.*
