## APPENDIX 1

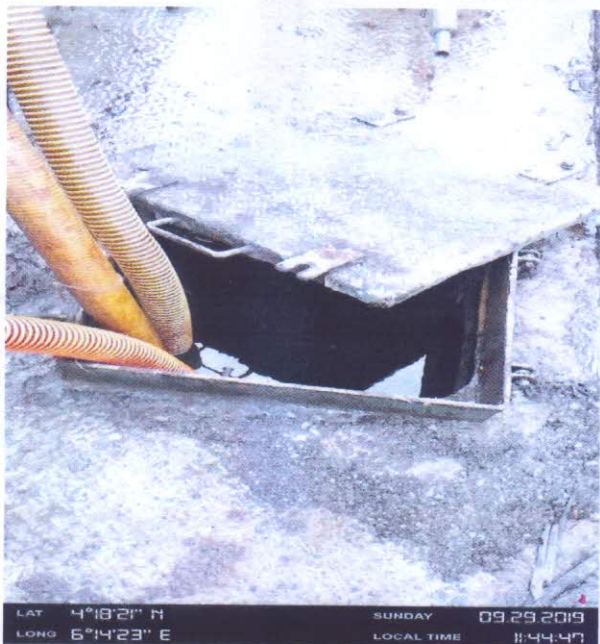
**SPILL POINT ON ARRIVAL.**

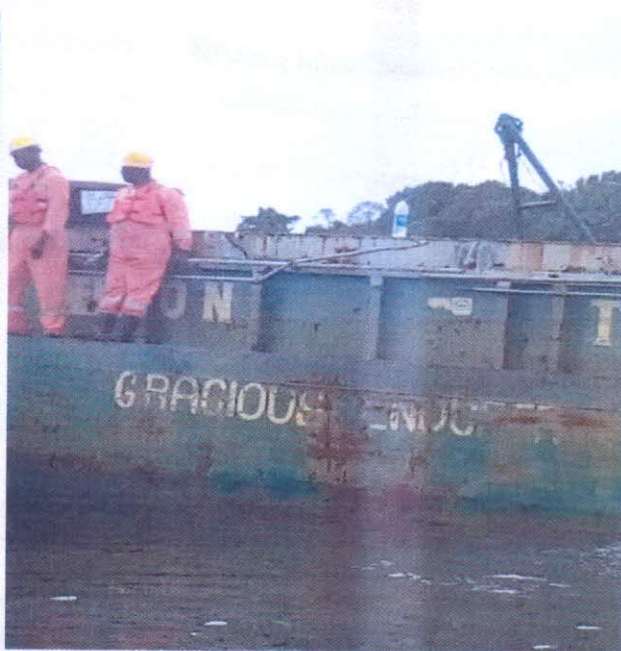
**LEAKING CRUDE OIL STORAGE BARGE.**

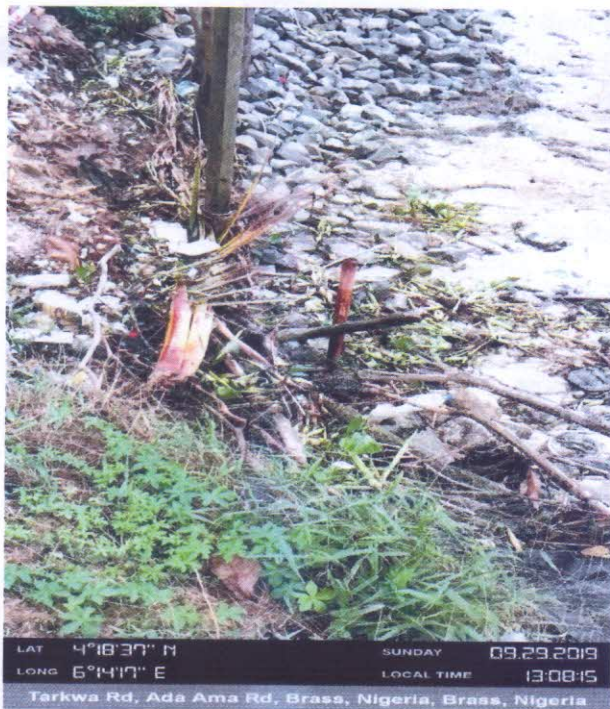
**AREA AROUND TAKWA BEACH.**

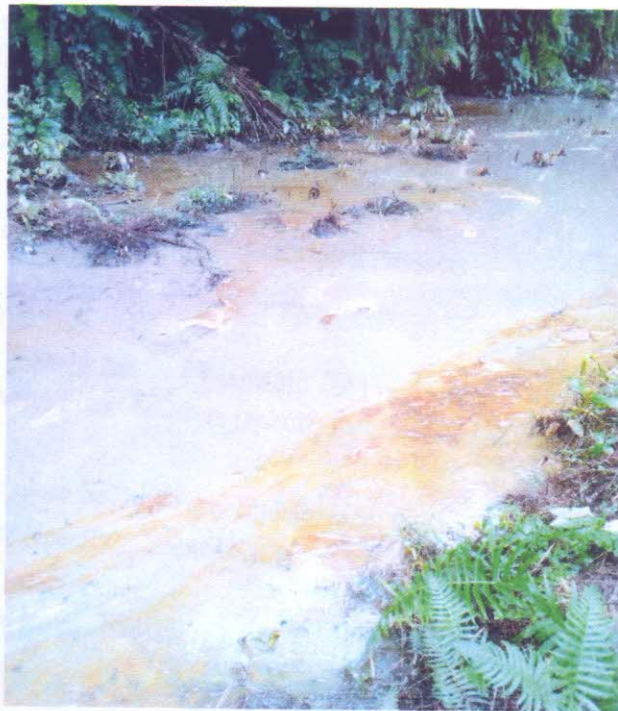
**OIL ON WATER BODY AND VEGETATION.**
