**APPENDIX 1**

**OIL THIEVES CAMP**

**APPENDIX 2: PICTURES FROM JIV POINT.**

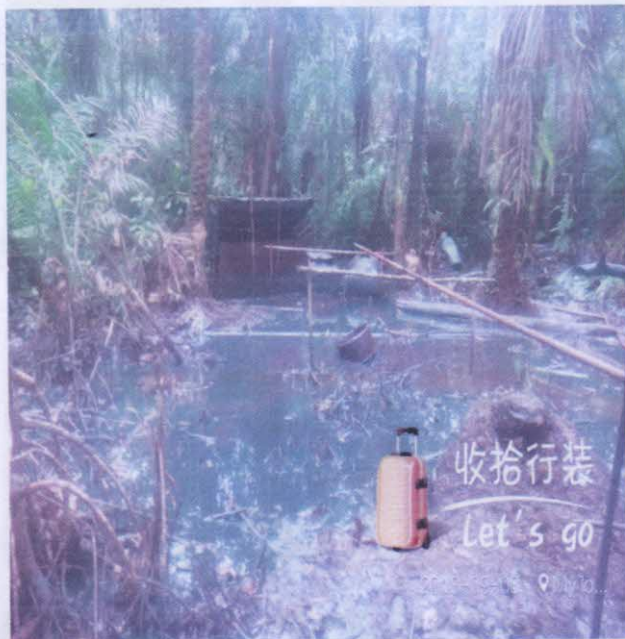
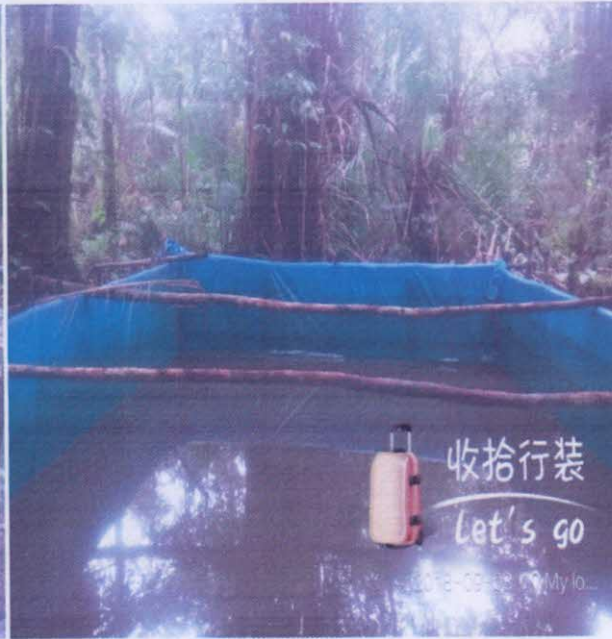
**CAMP IS HIGHLY POLLUTED.**

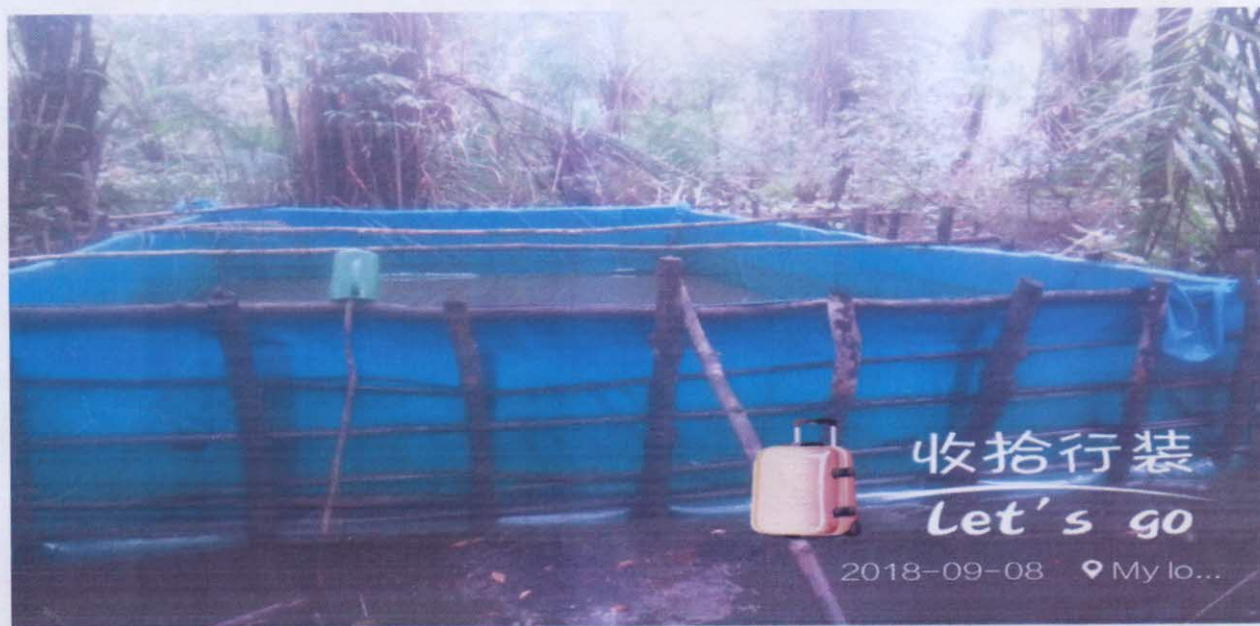
**CRUDE RESERVIOR AT THE CAMP**

**THE RESERVIOR AT THE ILLEGAL REFINERY CAMP FROM ANOTHER ANGLE.**

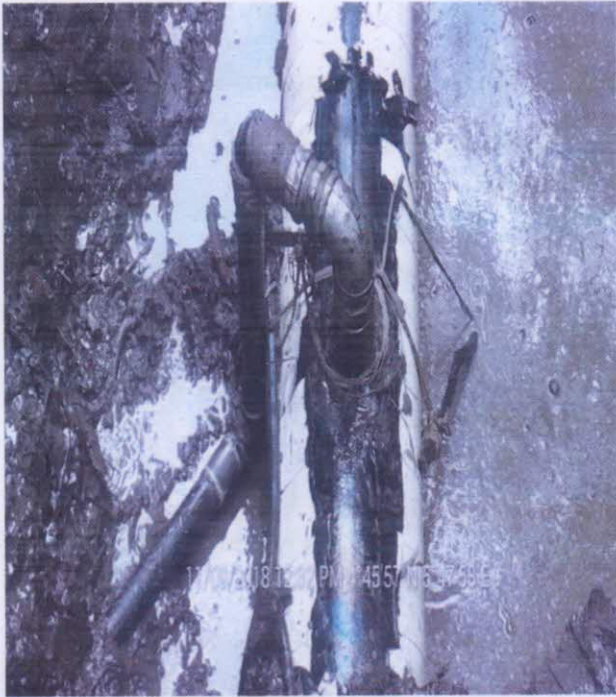
**2"VALVE AND PIPE LEADING TO THE CAMP.**
