## SOME PHOTOGRAPHS TAKEN DURING THE JOINT INVESTIGATION VISIT

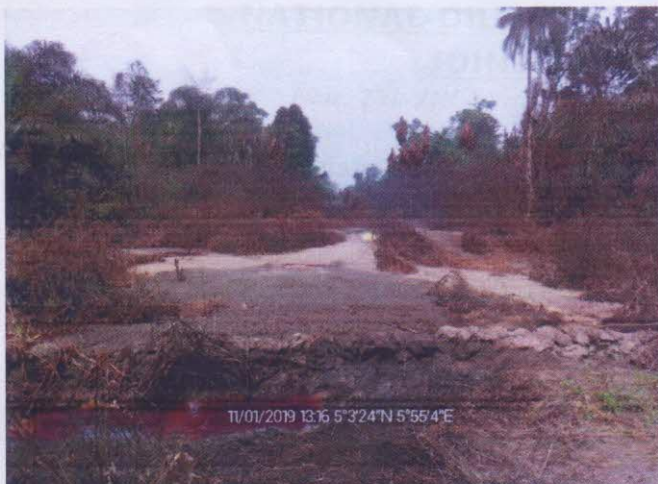
Fig A: Incident Area

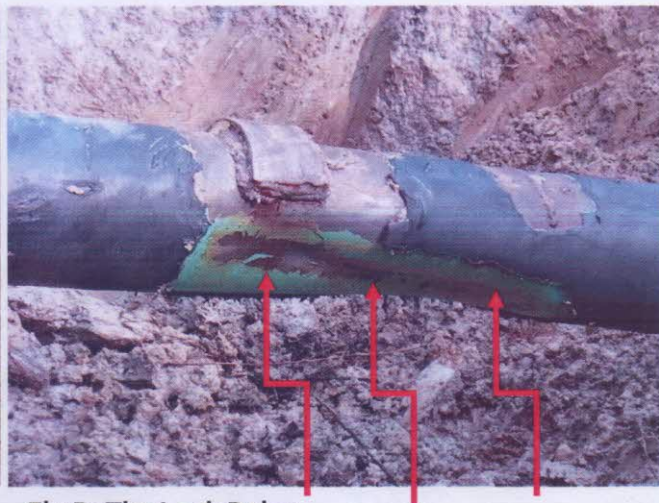
Fig B: The Leak Point

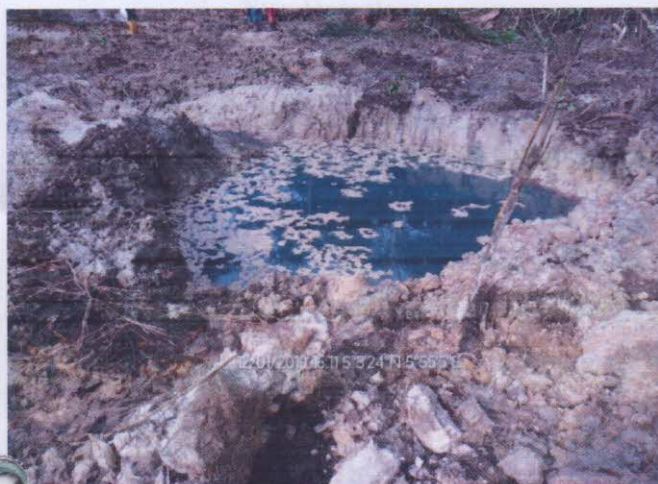
Fig C: Containment Pit

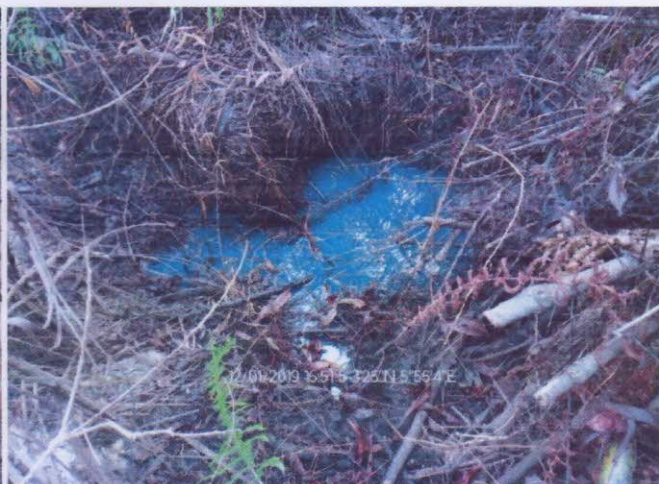
Fig D: Condensate Impacted Area
