**CTURE TAKEN AT SITE**

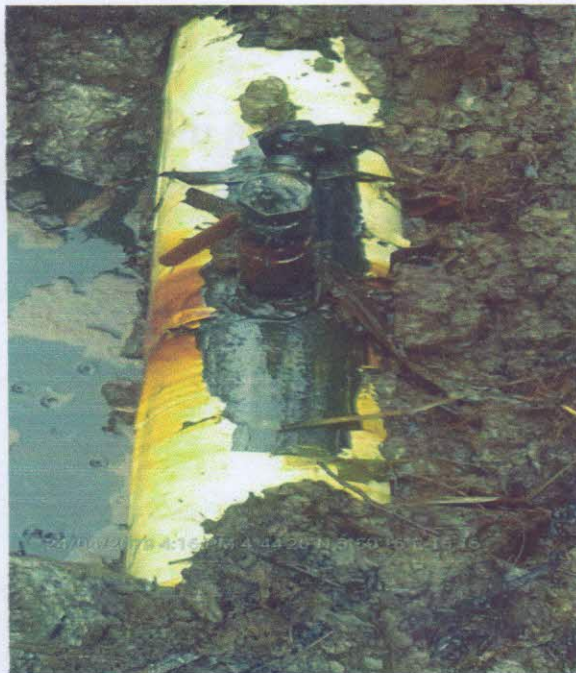
**PIC 1. On Excavation**

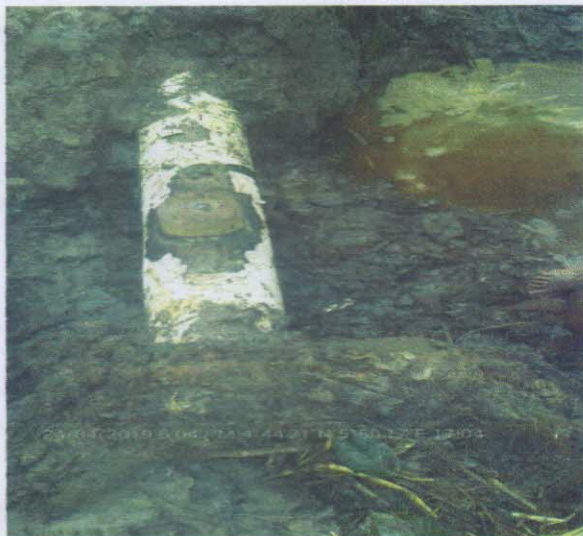
**Pic 2. 2" Valve on found at 12 'O'clock Position**
