PICTURES TAKEN AT SITE:

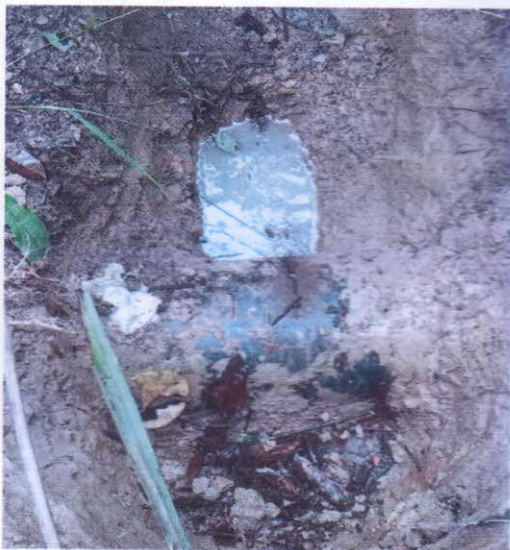
SPILL POINT BEFORE EXCAVATION:fig1

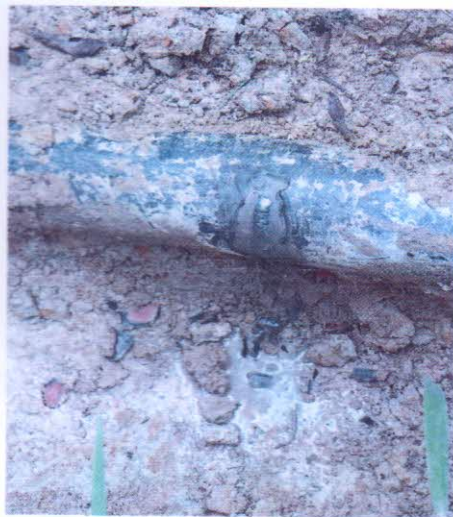
SPILL POINT DURING EXCAVATION:fig2

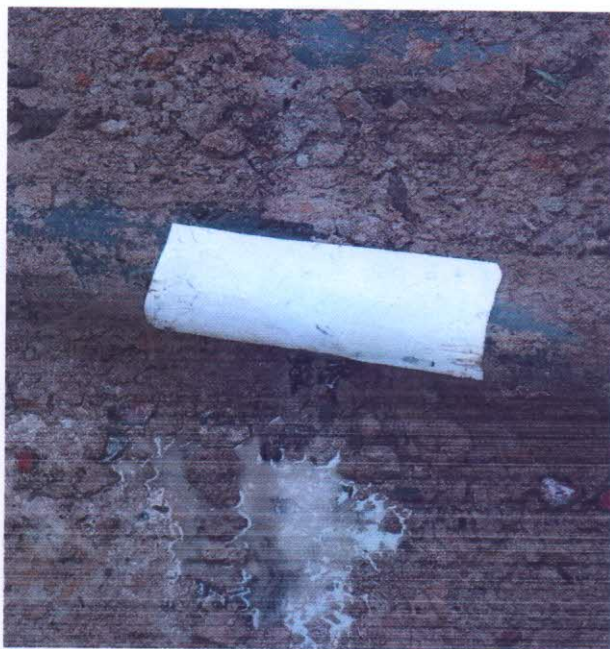
SPILL POINT AFTER REPAIRS:fig3
