PICTURES TAKEN AT SITE:

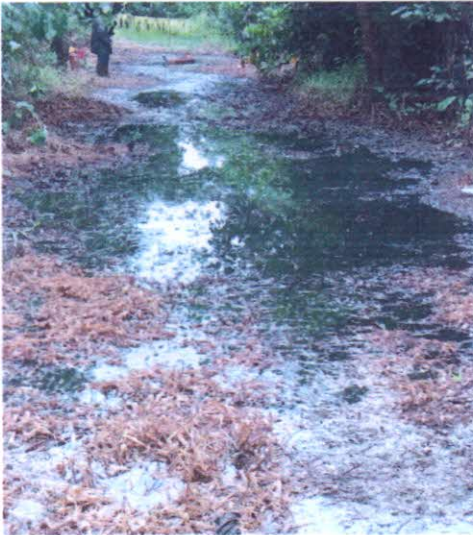
AREA IMPACTED: fig1

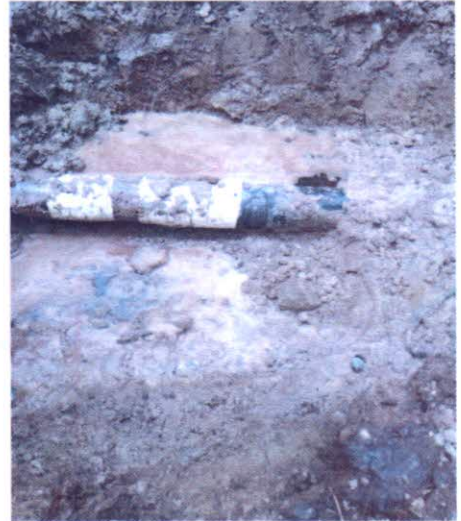
SPILL POINT AFTER EXCAVATION: fig2
