**PHOTOGRAPH TAKEN DURING THE JOINT INVISITIGATION VISIT AT ELEPA**

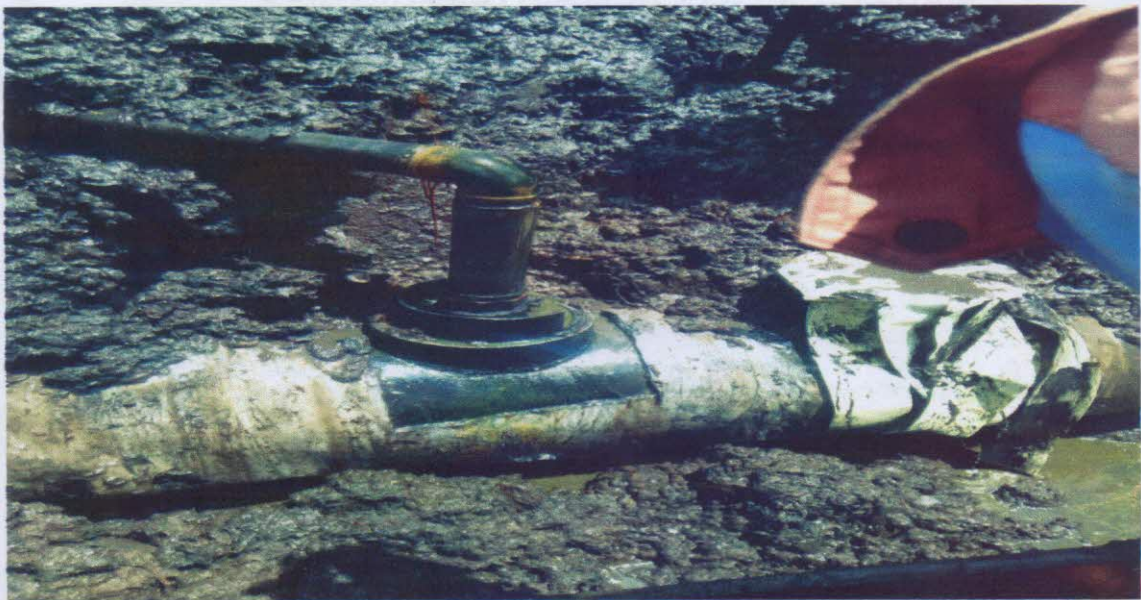
**THE SPILL POINT AFTER EXCAVATION**
