PHOTOGRAHS TAKEN DURING THE JOINT INVESTIGATION VISIT.

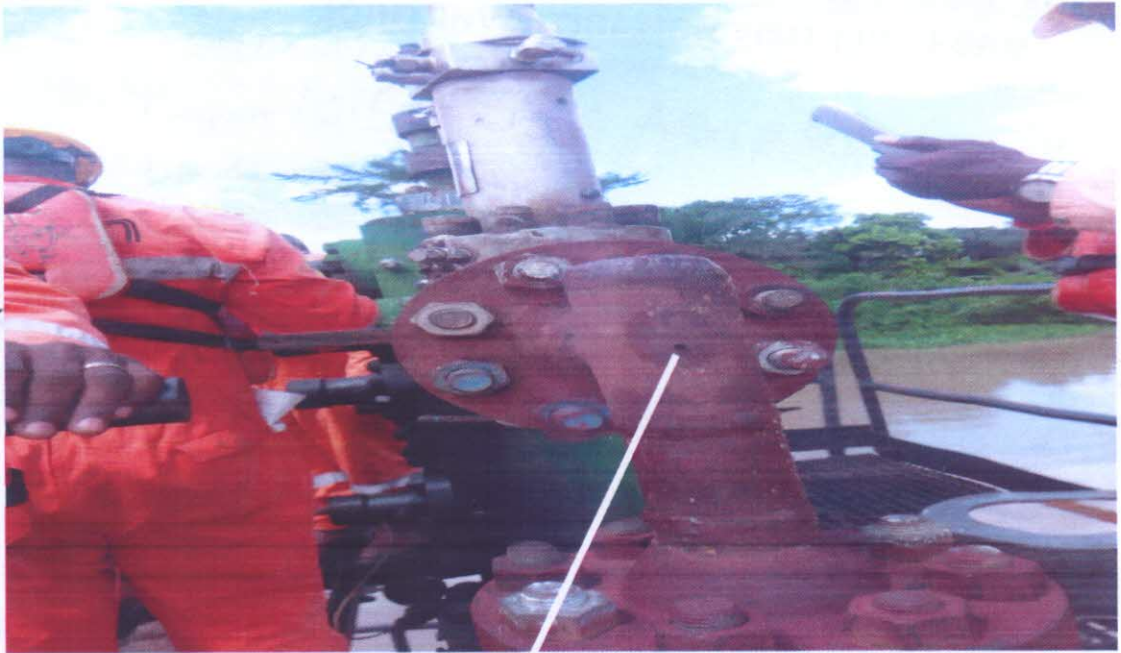
The area were the gas escape through a pin hole leakage at Wellhead Flange Spool, as a result of corrosion.

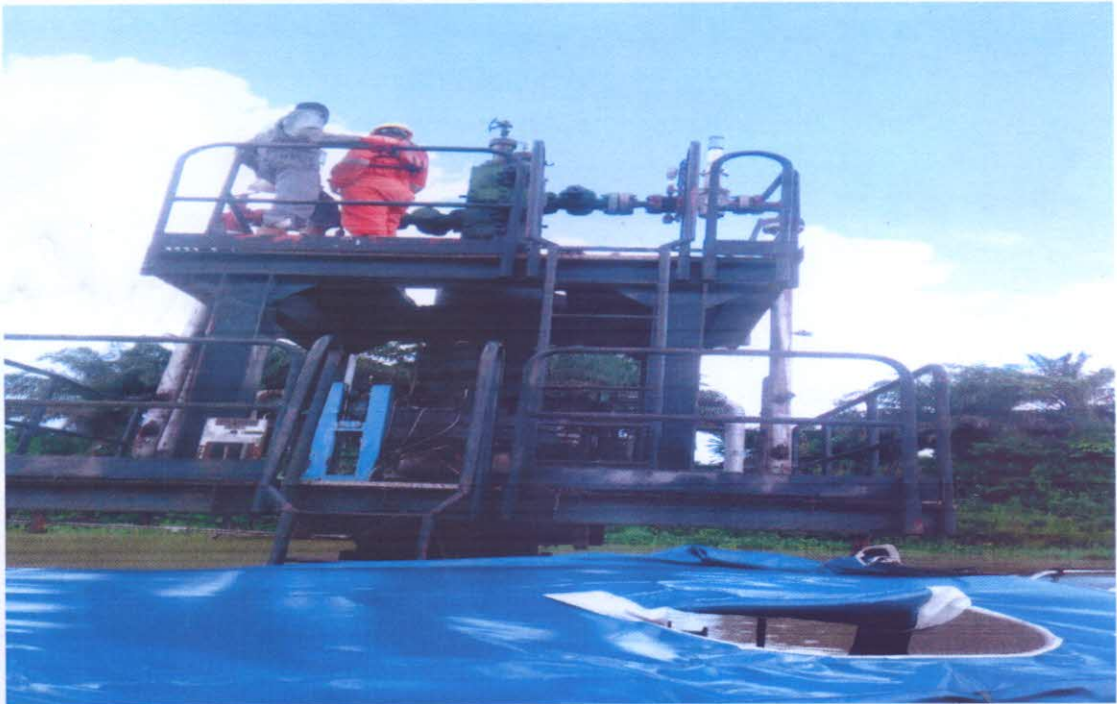
An area view of Obama Wellhead 12 at Obama Flow Station
