## PICTURE TAKEN AT SITE

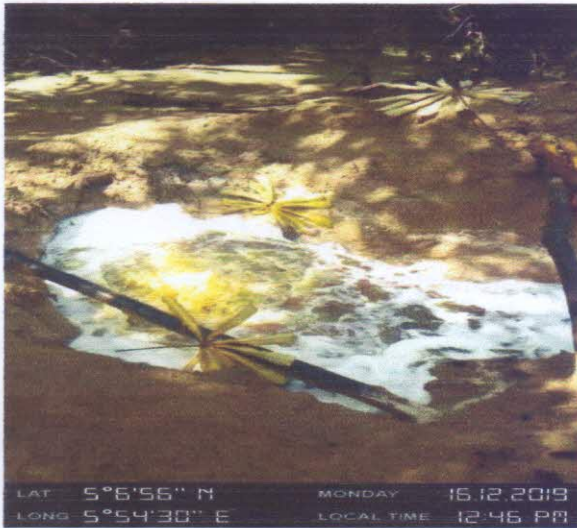
**PIC 1:** Before excavation

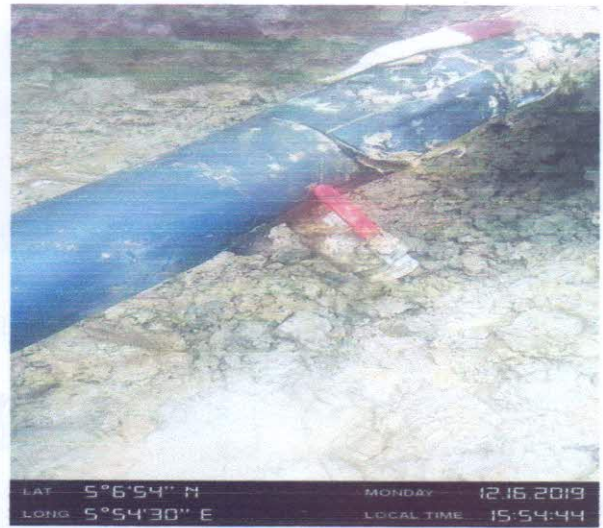
**Pic 2:** After excavation 3" Ball valve found.
