**PICTURE TAKEN AT SITE**

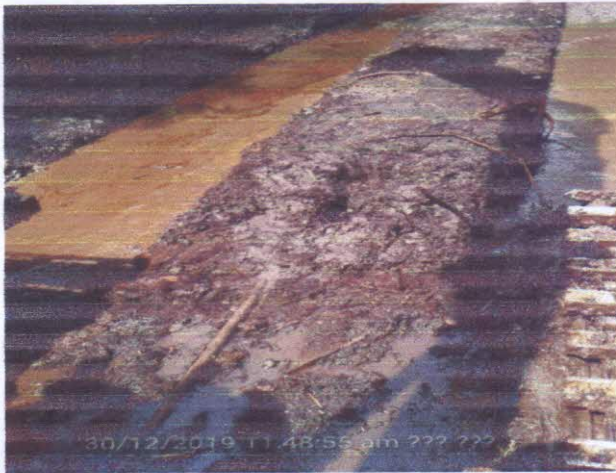
**PIC 1. On Arrival**

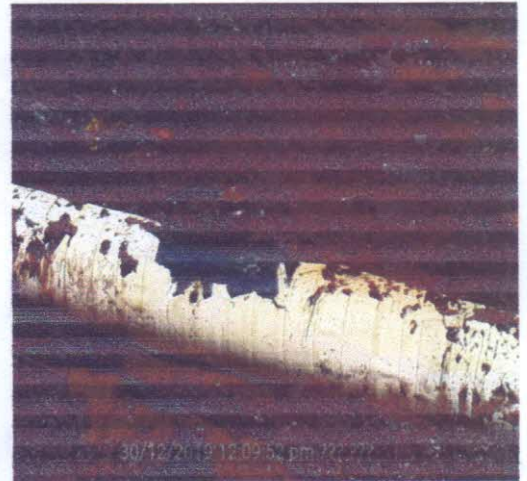
**Pic 2: 2" Valve on found at 12 'O'clock Position**

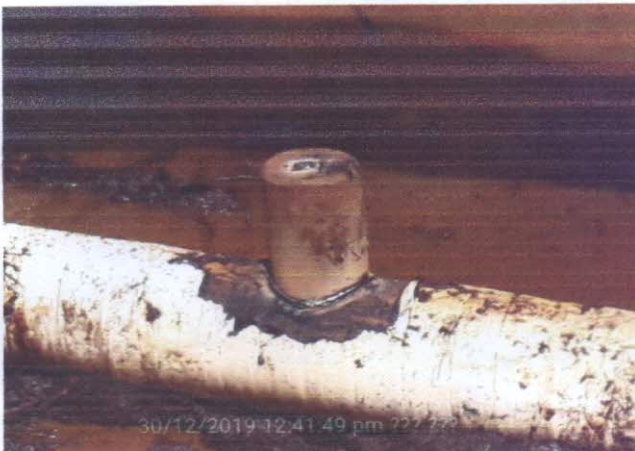
**Pic 3. Repair work**

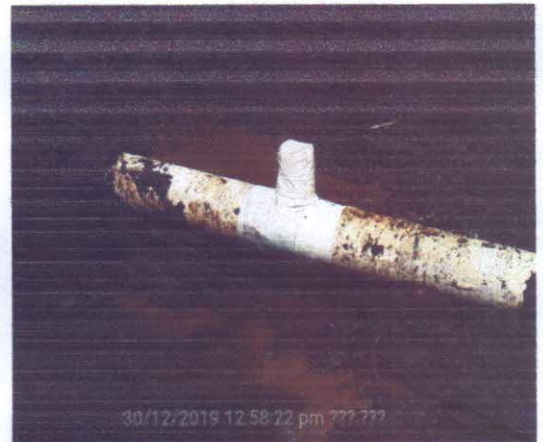
**Pic 4: Repair Work**
