**APPENDIX A**

*PHOTOGRAPHS TAKEN DURING JIV AT 6" OGBOINBIRI/TEBIDABA PIPELINE AT KEMEBIAMA IN SOUTHERN LOCAL GOVERNMENT AREA OF BAYELSA STATE.*

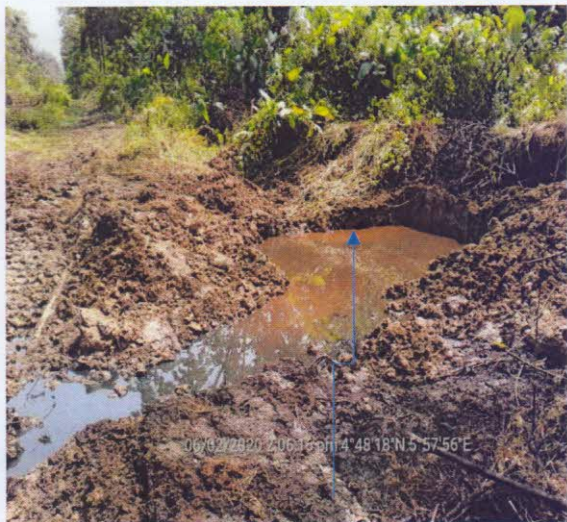
**BEFORE EXCAVATION**

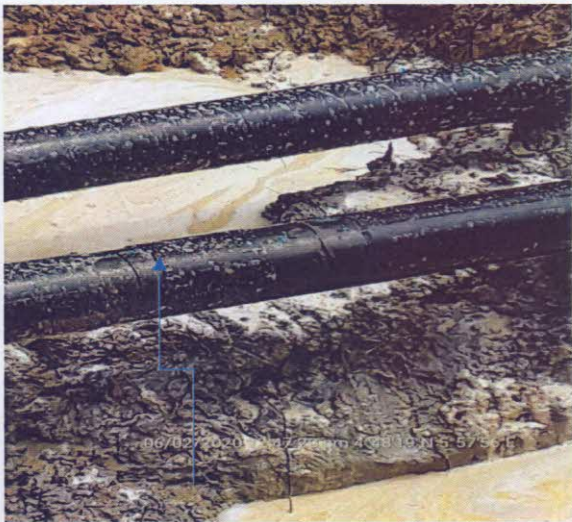
**SPILL POINT (AFTER EXCAVATION)  
HACKSAW CUTS**

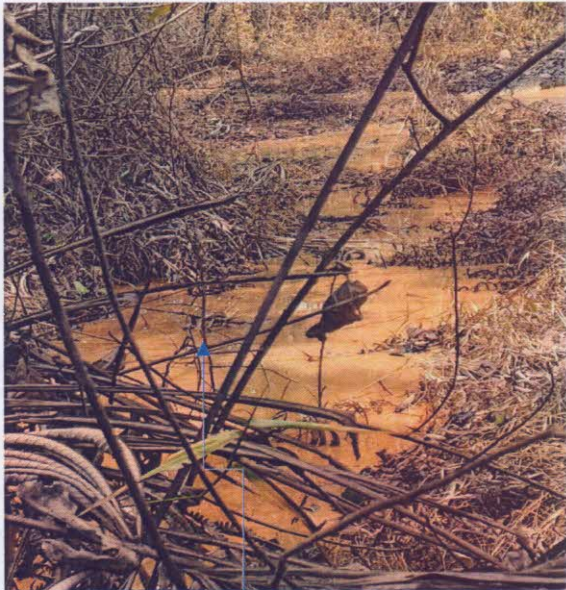
**IMPACTED ENVIRONMENT**
