## APPENDIX A

PHOTOGRAPHS TAKEN DURING JIV AT 6" Deep 6 Ogboinbiri Flowline At Ogboinbiri In Southern Local Government Area Of Bayelsa State.

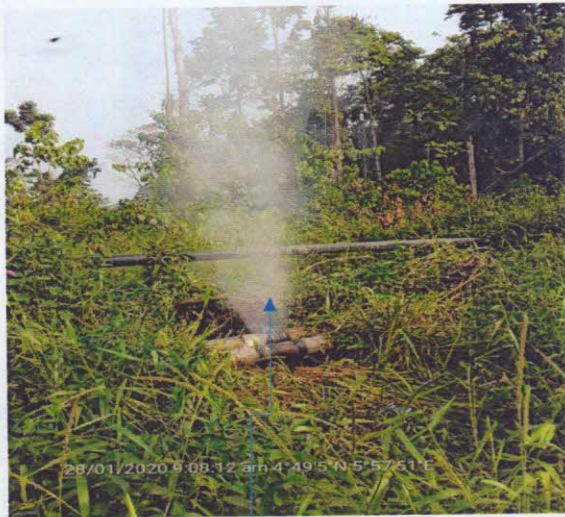
GASEOUS EMISSION FROM SPILL POINT

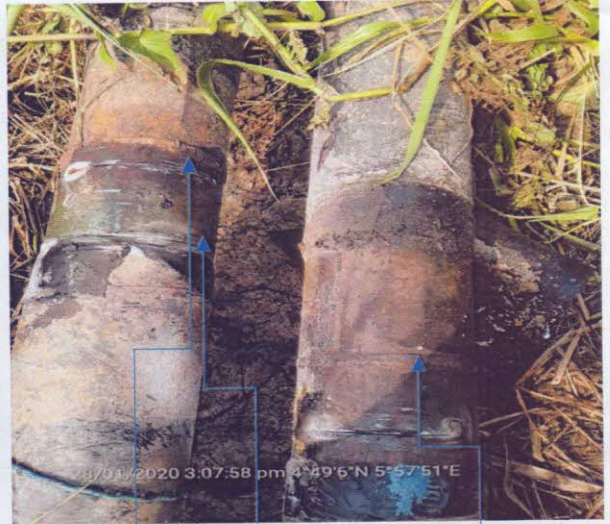
THREE HACKSAW CUTS ON THE FLOWLINE

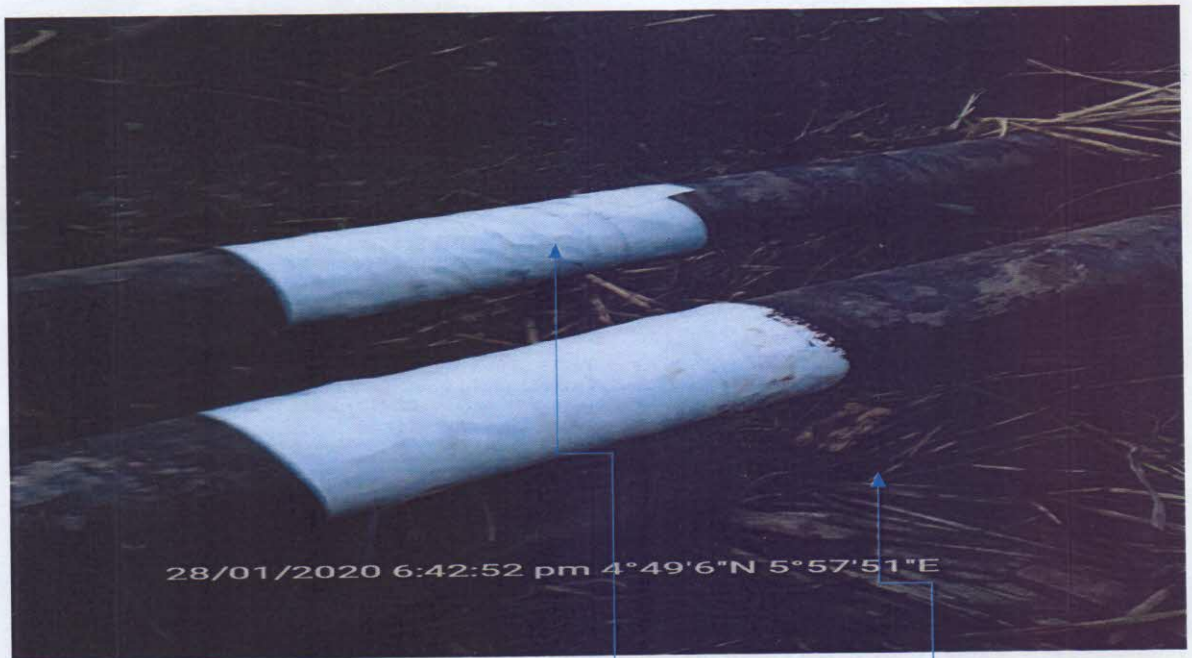
REPAIR POINT (WRAPPED)

WITHERED VEGETATION
