# SOME PHOTOGRAPHS TAKEN DURING THE JOINT INVESTIGATION VISIT

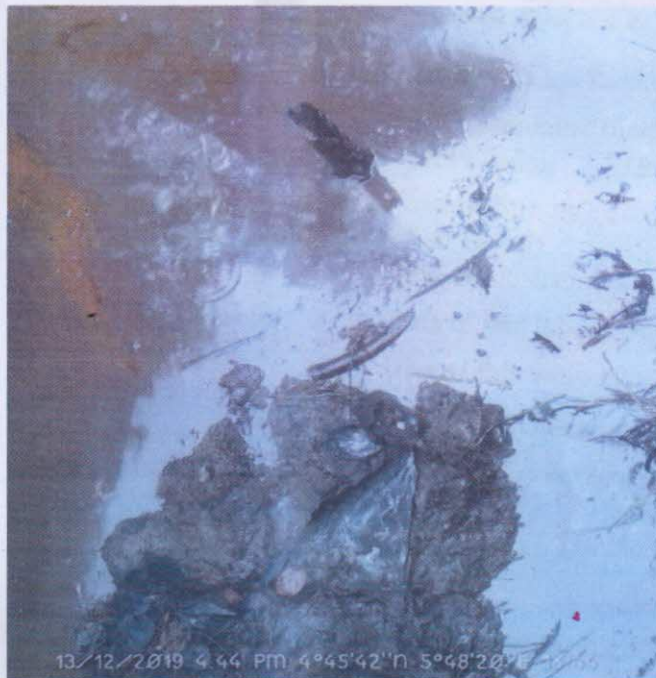
Fig A: Incident Area on arrival of the JIT

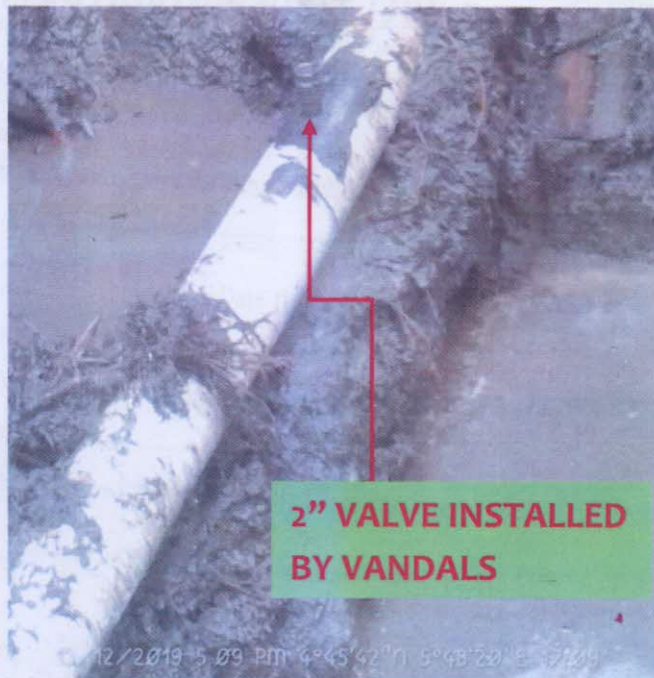
Fig B: Incident Facility after excavation

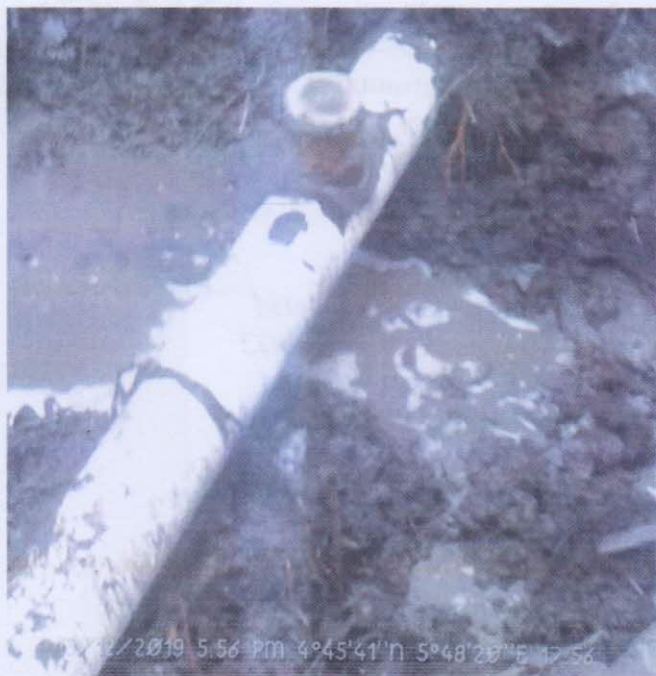
Fig C: Incident facility during repairs

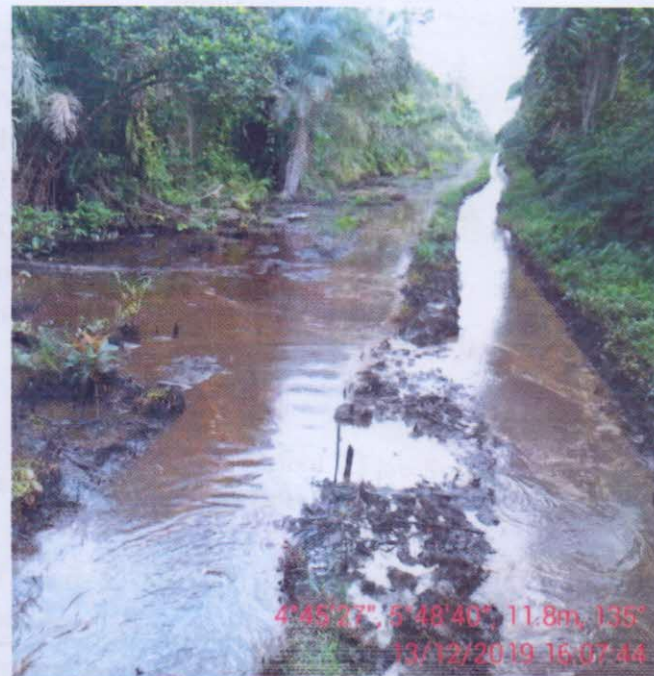
Fig D: Old crude/impact sighted by JIT within & outside RoW
