# SOME PHOTOGRAPHS TAKEN DURING THE JOINT INVESTIGATION VISIT

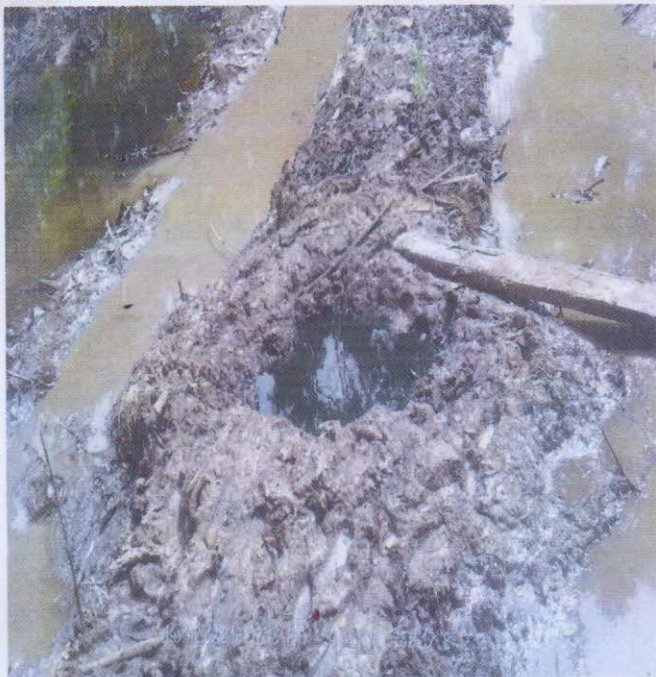
Fig A: Incident Area on arrival of the JIT

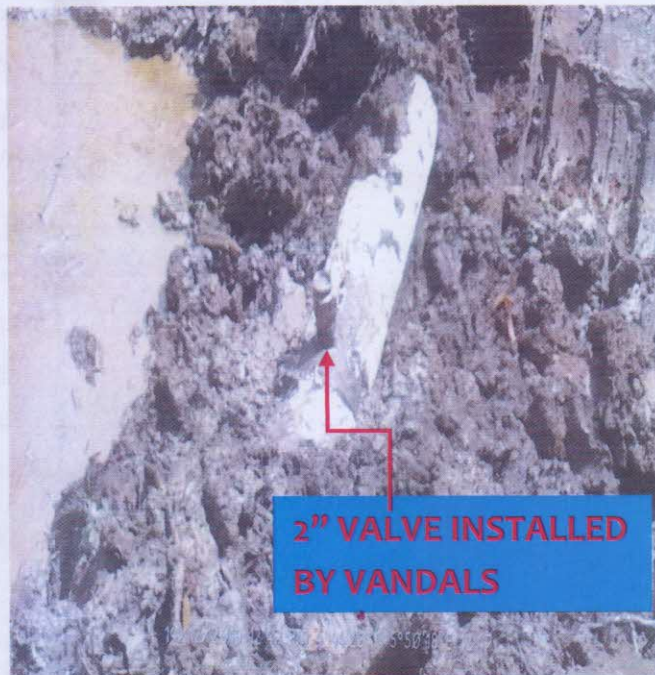
Fig B: Incident Facility after excavation

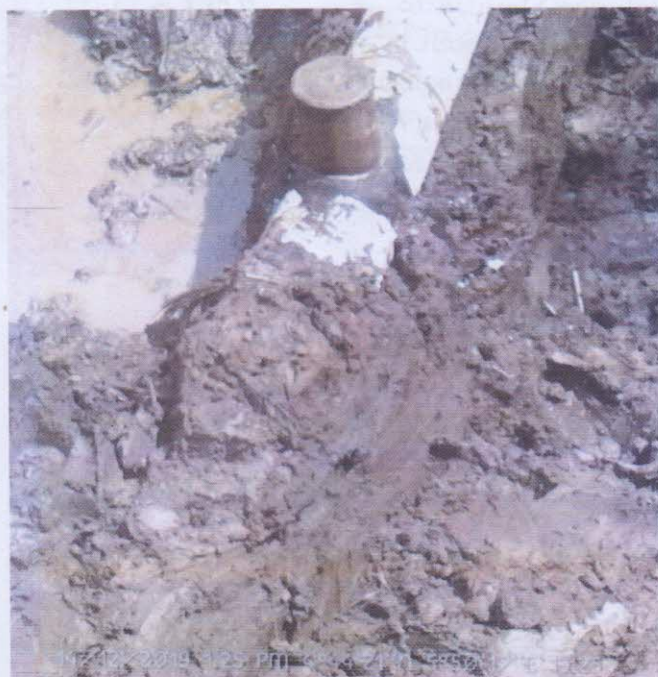
Fig C: Incident facility during repairs

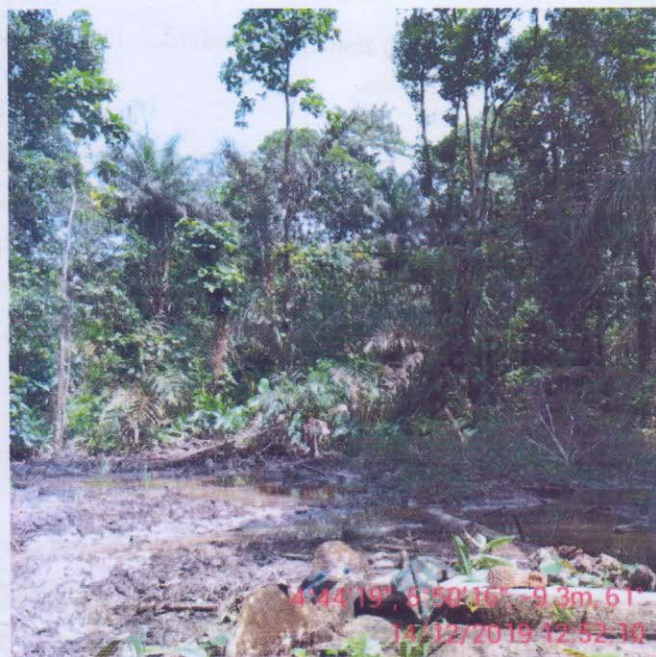
Fig D: Adjoining environment
