## **Spill Event Summary**

## Technical Explanation

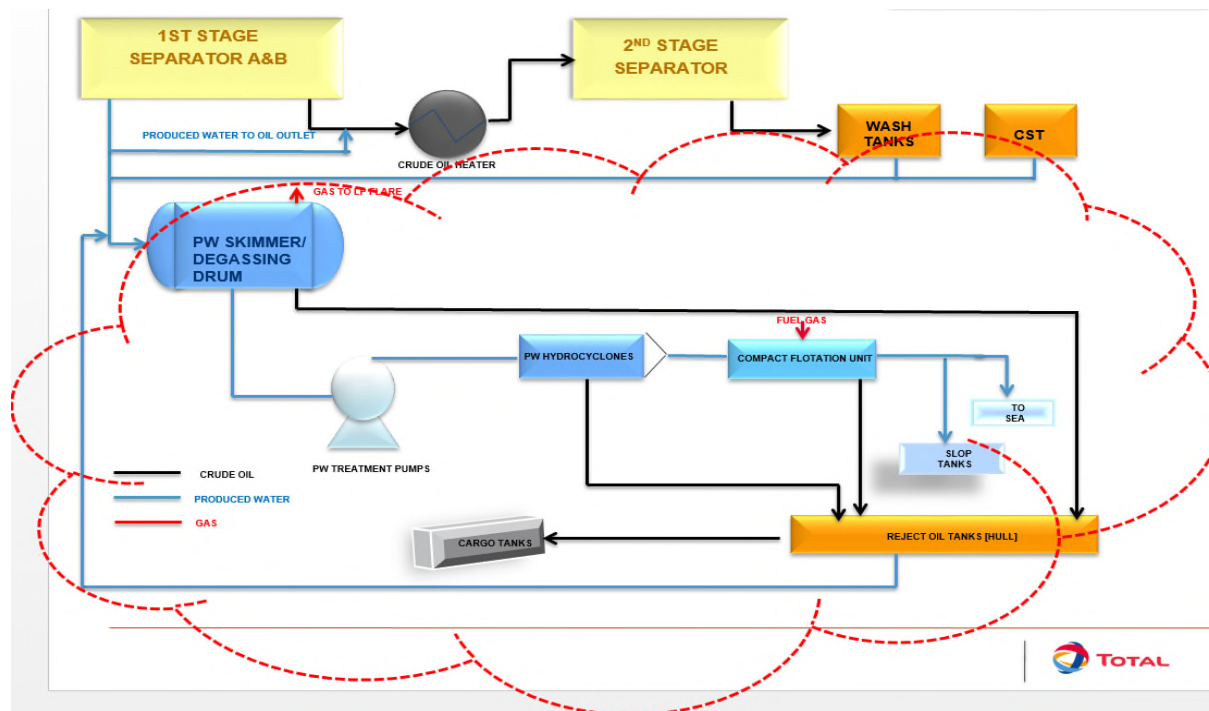
Figure 1: PRODUCED WATER TREATMENT SYSTEM

After the shutdown on 11<sup>th</sup> July, there has been accumulation of deposits (analysed as Calcium Naphthenates) in the 1<sup>st</sup> Stage separators which rapidly clogs the strainers on the water recycle line to oil outlet (See Fig. 1). In order to continue operating the separators in 3-phase and not transfer the deposits to the oil outlet, the 1<sup>st</sup> Stage Separators water outlet to degassing drum was opened as per design. However, due to the presence of naphthenates, the quality of water from the separators was quite poor, but still within the treatment capacity of the degassing drum (designed to treat up to 2000ppm at inlet), hence, the discharge water overboard was still within specification.

On 28<sup>th</sup> July, the Process & Safety LDT's (Guided Wave Radar Type which actually measures the level in the drum than the interface) started malfunctioning, giving spurious readings, deviations and sometimes loop fault resulting in complete loss of readings. The Maintenance Instrument team began troubleshooting and logged data from the transmitters, hence the operator had to rely on LT in the vessel oil compartment and local level gauge on the vessel when there is complete loss of readings.

On the 30<sup>th</sup> night, the level indication in the degassing drum zeroed out and it was assumed that the transmitters were faulty again so the operator regulated the flow through the degassing drum using the LV's downstream the hydrocyclone. It is believed that either of the following may have actually occurred:

- The degassing drum level may have actually been very low at this point and there was no sufficient residence time for the oily water in the vessel OR

- The quality of oily water from 1<sup>st</sup> Stage Separator B deteriorated, hence water with high concentration of oil was sent to the degassing drum which exceeded the treatment capacity of the vessel.

It is difficult to ascertain the real cause of the poor water quality discharged as the online analysers across the treatment system are not reliable. Similarly, the complexity of regulating the vessel pressure manually due to lack of automatic pressure regulation further complicates the operation of the produced water treatment system. The vessel pressure is controlled manually by adjusting the valve on the line to flare to prevent exceeding the operating pressure and yet maintain sufficient pressure at the suction of the produced water treatment pump. Along the night, the online analyzer at discharge line reported a constant value around 28 ppm.

The following mitigations have since been implemented to prevent reoccurrence:

- Wash water flow to 1<sup>st</sup> Stage Separator B has been reduced to minimize quantity of oily water sent from the Separator to the produced water degassing drum
- Standing Instruction issued on the operation of the produced water treatment system which includes maintaining a high level in the drum, operating the drum level permanently on AUTO mode, frequent backwash of the hydrocyclones per shift, etc.
- Collection of reject water samples during night shift for visual checks until the online analysers are fixed.
- Instruction to divert produced water flow to Slop tank / CST's if the Degassing drum level transmitters goes faulty or indicates doubtful readings.

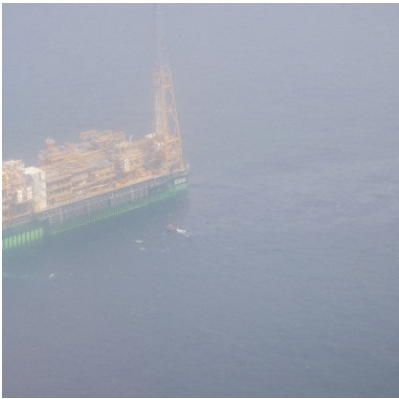
| <i>Sheens at EGINA</i> | <i>Sheens at AKPO</i> | <i>Front end of the Sheen</i> |

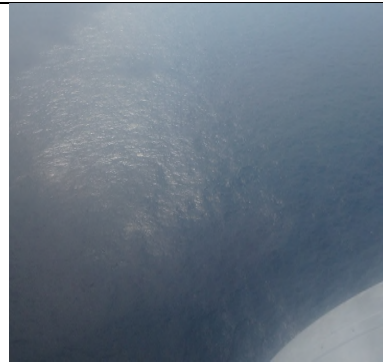
| <i>Remaining light traces at Egina</i> | <i>Remaining light traces at Egina</i> | <i>No longer sheen at 10NM NE from Akpo</i> |
