**REPORT OF EVENT RESPONSE TO AN OIL SPILLAGE/LEAKAGE INCIDENT AT  
IYANA-ODO, ALIMOSHO LOCAL GOVERNMENT AREA OF LAGOS STATE ON THE  
23<sup>RD</sup> OF AUGUST, 2020**

- i. **COMPANY:** Nigerian Pipelines and Storage Company (NPSC)
- ii. **HEAD OFFICE:** NNPC Towers, Central Business District, Garki, Abuja
- iii. **AREA OFFICE:** NPSC Mosimi, Ogun State
- iv. **FACILITY:** Petroleum Product Pipeline (Atlas Cove-Mosimi)
- v. **PURPOSE OF VISIT:** Incident Assessment/Response monitoring
- vi. **INCIDENT:** Pipeline tampering/Leakage of product
- vii. **DATE OF INCIDENT:** 23<sup>rd</sup> August, 2020
- viii. **CAUSE OF INCIDENT:** Vandalism
- ix. **PRODUCT:** Premium Motor Spirit (PMS)
- x. **QUANTITY SPILLED:** Not yet quantified

Iyana-Odo, Alimosho Local Government Area, Lagos

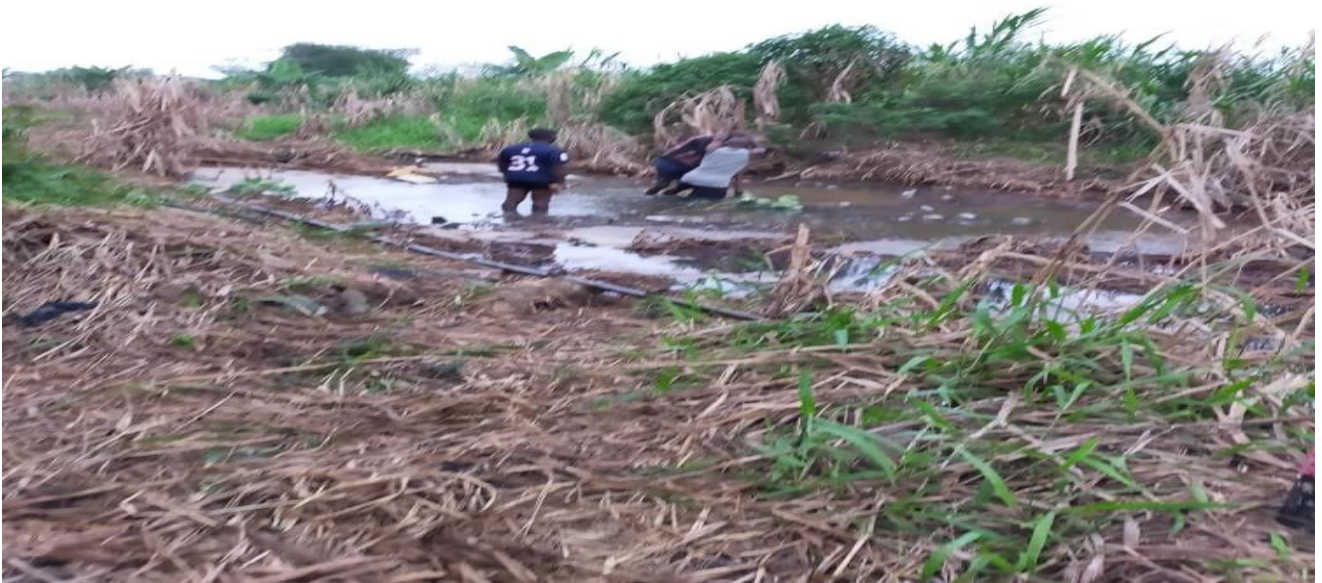
**Pegging the affected portion of the pipeline**

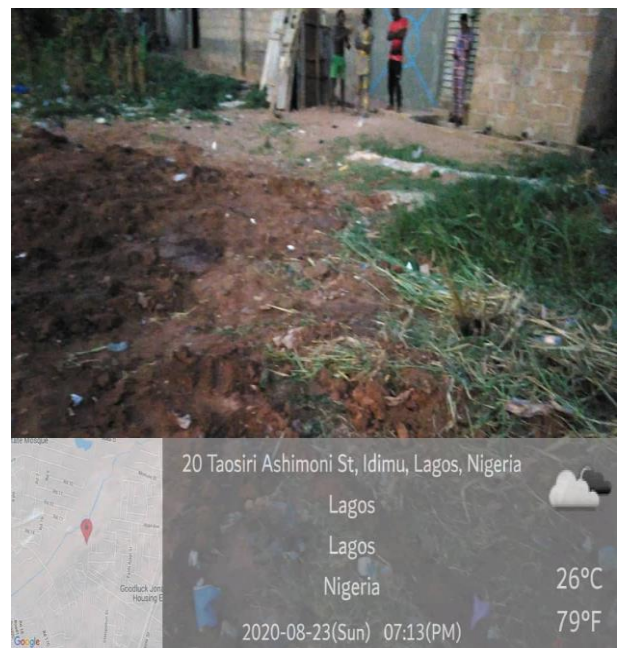
**Residential Building**
