**REPORT OF POST CLEAN-UP VERIFICATION AND CERTIFICATION (PCVC) EXERCISE OF SPDC IMPACTED SITE ON 10" DIEBU CREEK-NUN RIVER PIPE LINE @ OPOROMA IN SOUTHERN IJAW L.G. AREA OF BAYELSA STATE.**

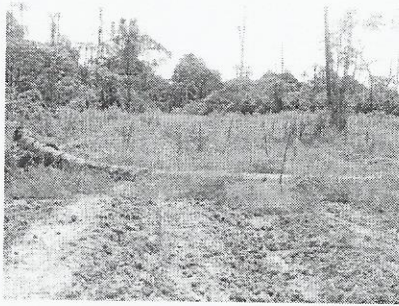
1. The PCI Site was within the Rain Forest Terrain at Oporoma, about 30 Meters away from Incident Number 2014\_1221605A.(See Fig. 1a)

Fig. 1a Spill Point Area

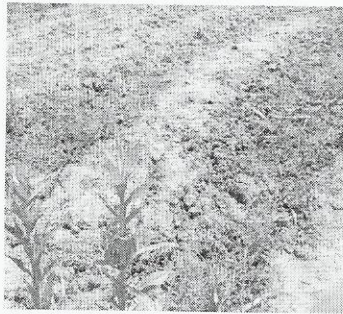
2. Evidence of tiled or brought-in Soil was noticeable at Site around the Spill Point (See Fig. 1b)
3. The Soil was not wet with Oil and no Sheen was noticed around the Spill Point.
4. No Oil stained Vegetation was observed. The Area has totally healed (See Fig. 1c)

Fig. 1b Tiled Soil

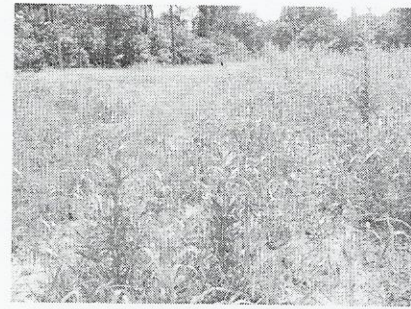
Fig. 1c Grasses around Spill Area
