# APPENDIX I

## SOME PHOTOGRAPHS TAKEN DURING THE JOINT INVESTIGATION VISIT (JIV)

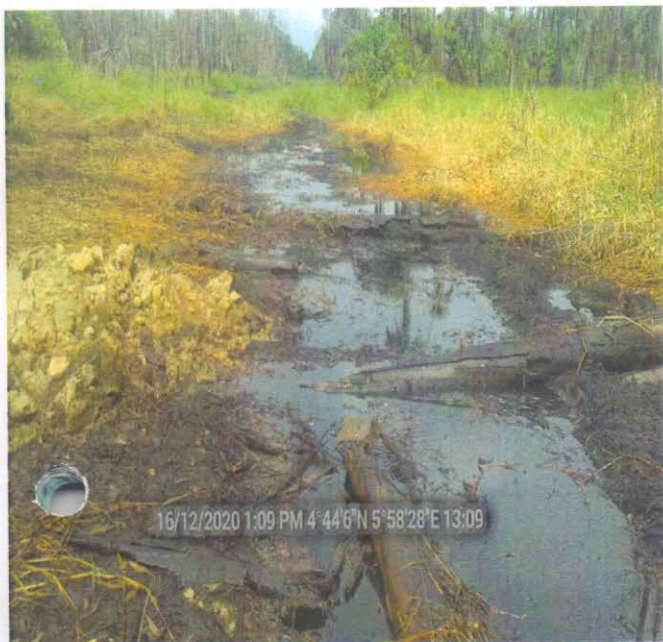
Fig A: Suspected Incident Area on arrival of JIT

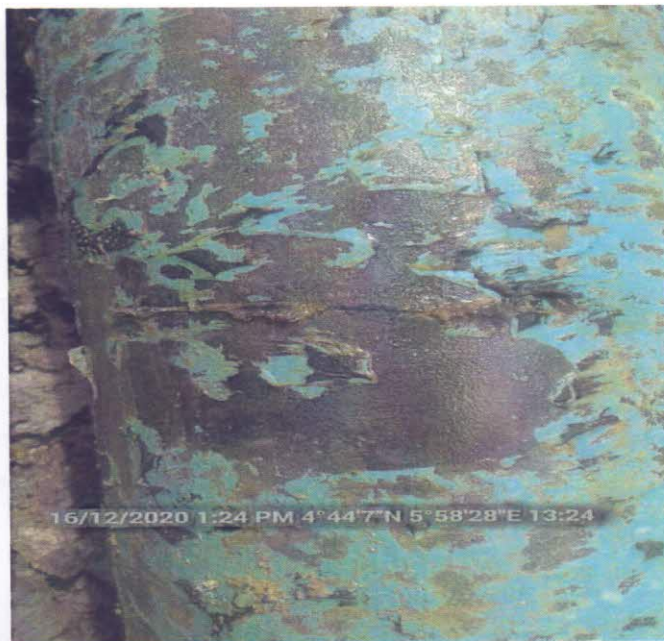
Fig B: Suspected Incident Facility shortly after excavation
