APPENDIX A:

PHOTOGRAPHS TAKEN DURING JIV AT 6" OGBOINBIRI/TEBIDABA PIPELINE AT OKPOTUWARI IN SOUTHERN IJAW LOCAL GOVERNMENT AREA OF BAYELSA STATE.

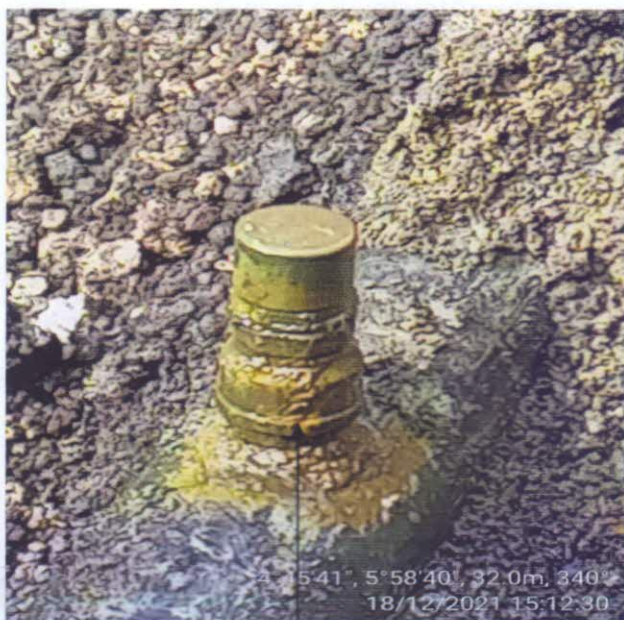
SPILL POINT

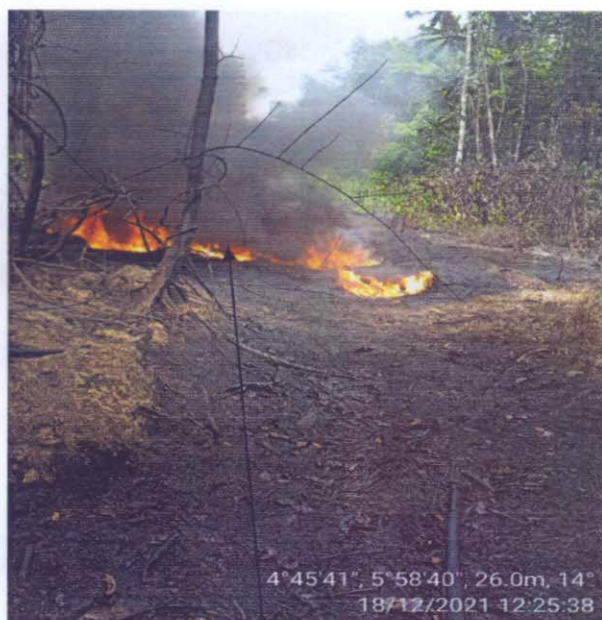
FIRE ON INCIDENT POINT

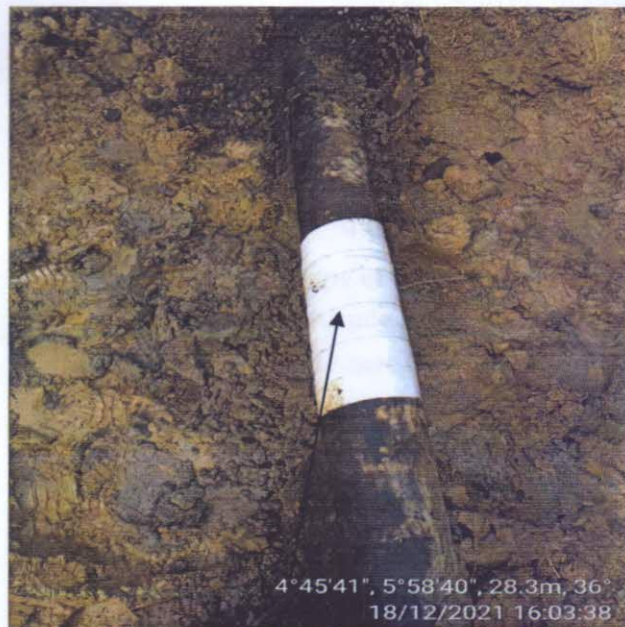
REPAIR POINT

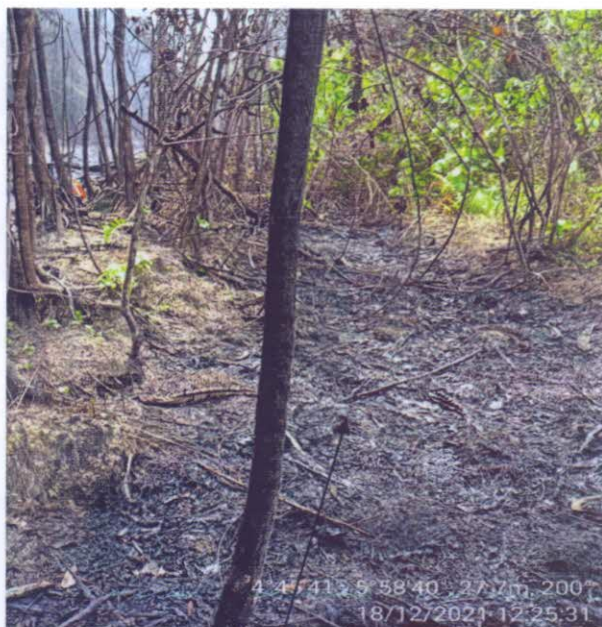
IMPACTED AREA
