# SOME PHOTOGRAPHS TAKEN DURING THE JOINT INVESTIGATION VISIT

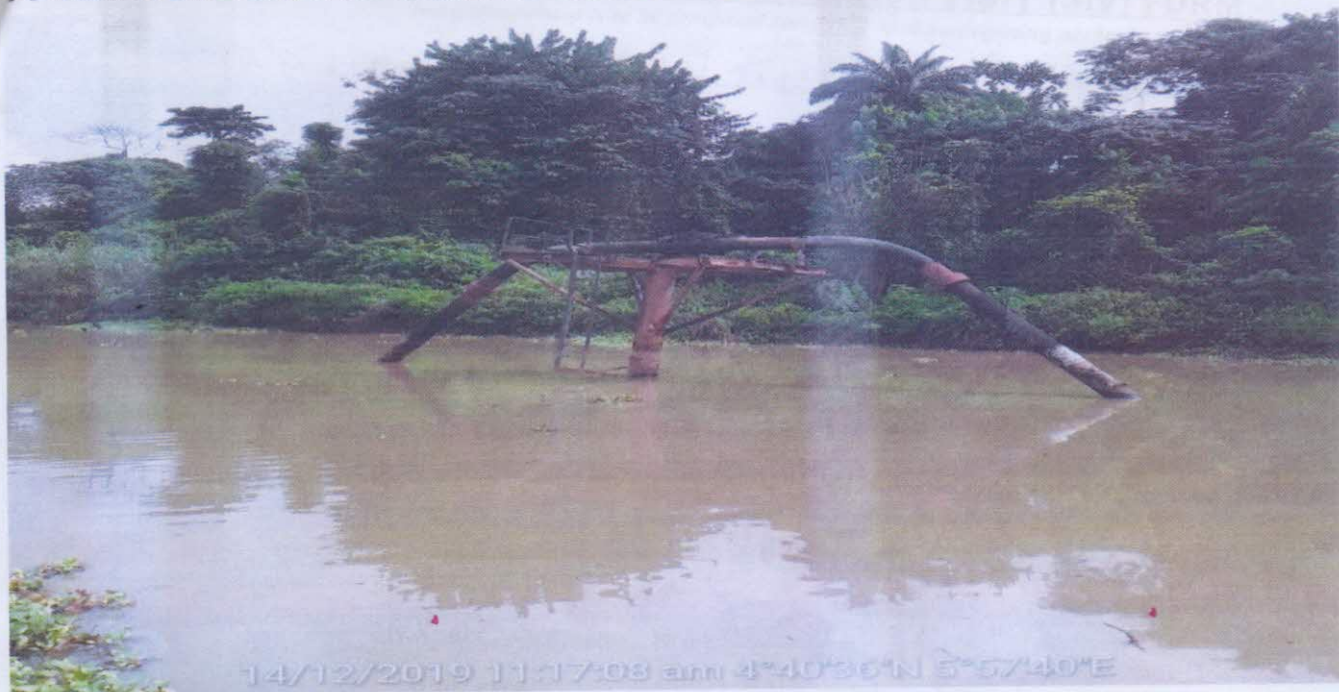
Fig A: Incident Area on arrival of the JIT

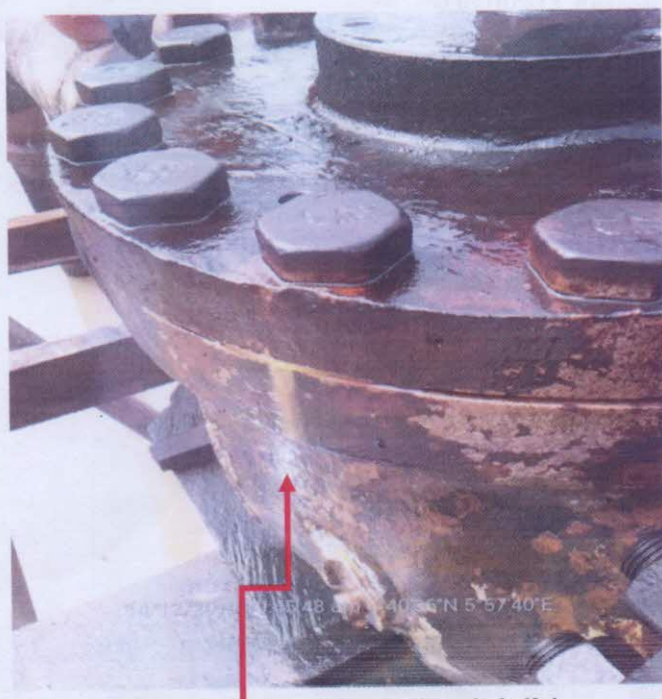
Fig B: Incident facility (insulating joint)/ leak point
