## APPENDIX A

PHOTOGRAPHS TAKEN DURING JIV AT 14" OGBOINBIRI /TEBIDABA PIPELINE AT  
IKEBIRI SOUTHERN IJAW LOCAL GOVERNMENT AREA, BAYELSA STATE.

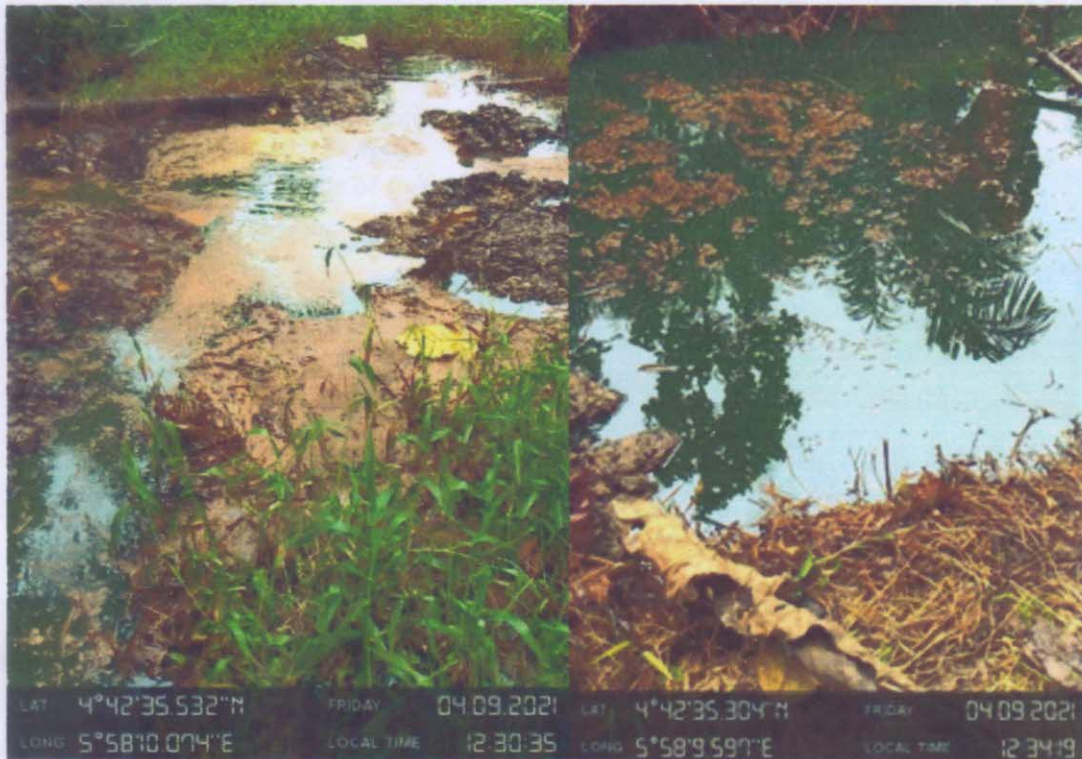
FIG. 1 SHOWING CRUDE OIL ON SPILL POINT

FIG.2 SHOWING CRUDE OIL ON SHALLOW DITCH

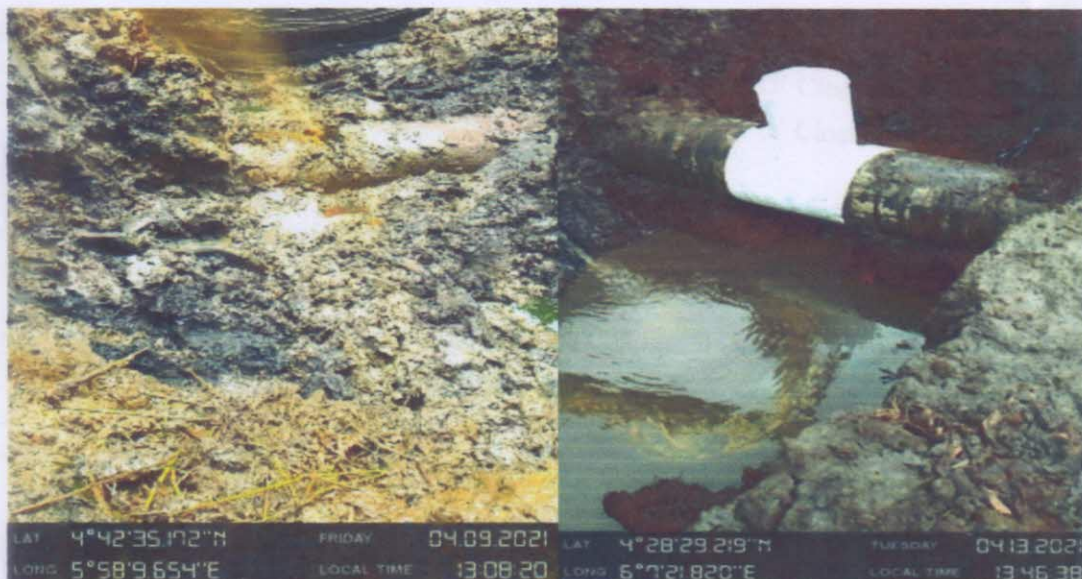
FIG.3 SHOWING 3" VALVE AT 12' O CLOCK

FIG.4 SHOWING THE SPILL POINT AFTER REPAIR
