## APPENDIX A

### PHOTOGRAPHS TAKEN DURING INSPECTION VISIT

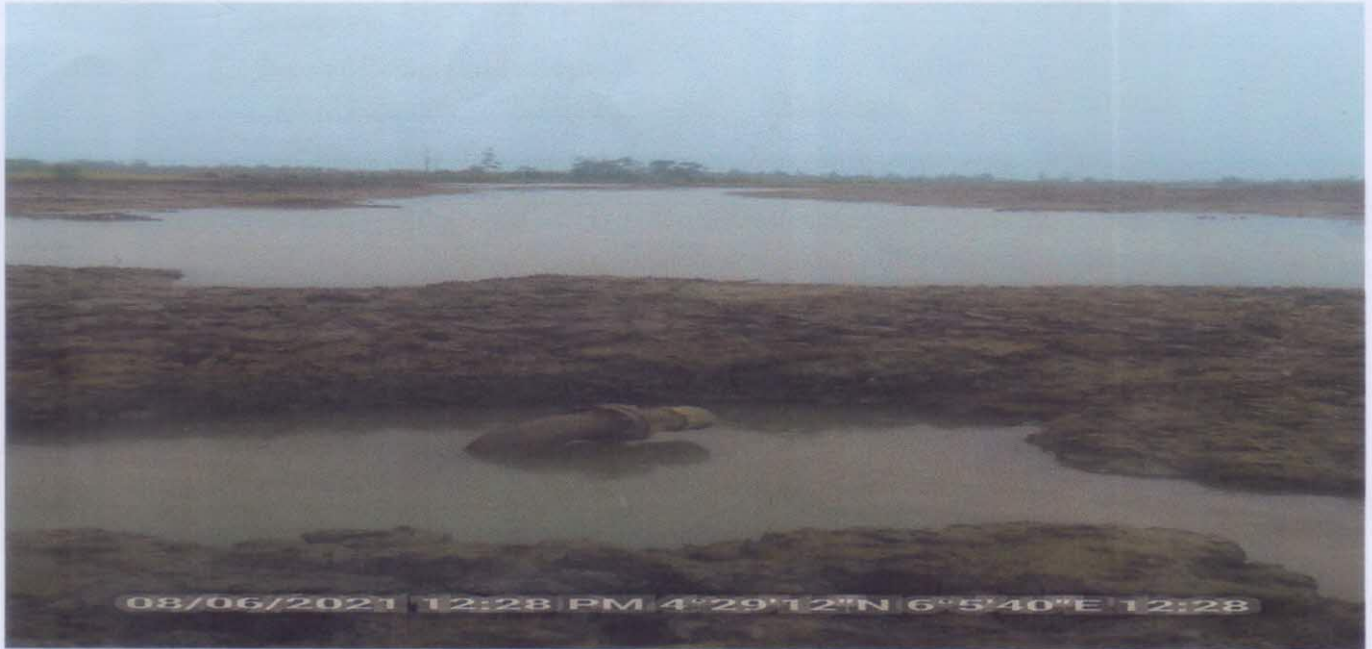
#### BEFORE EXCAVATION

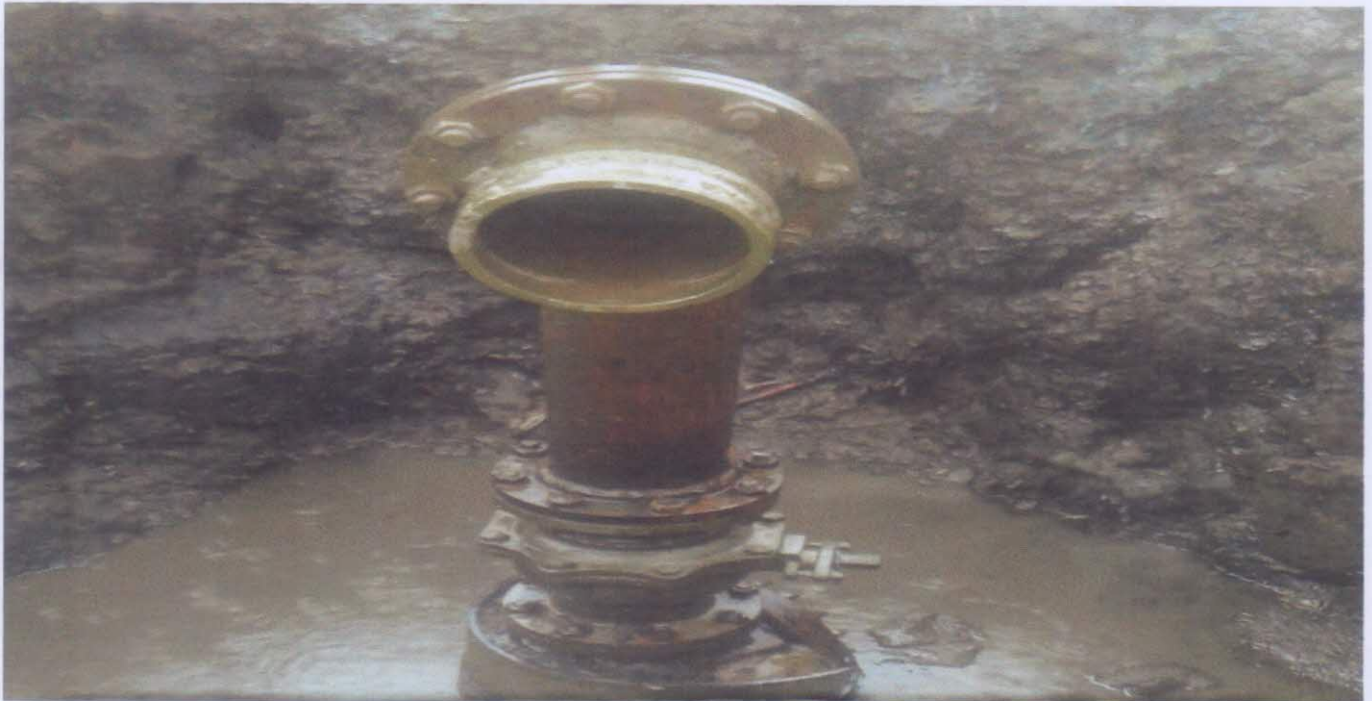
#### NON LEAKING POINT SHOWN
