## APPENDIX I

### SOME PHOTOGRAPHS TAKEN DURING THE JOINT INVESTIGATION VISIT (JIV)

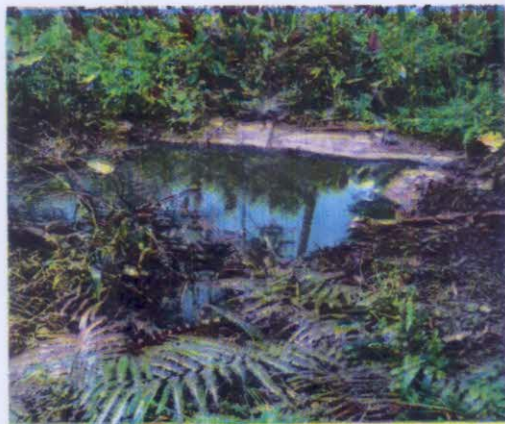
Fig A. SPILL POINT BEFORE EXCAVATION

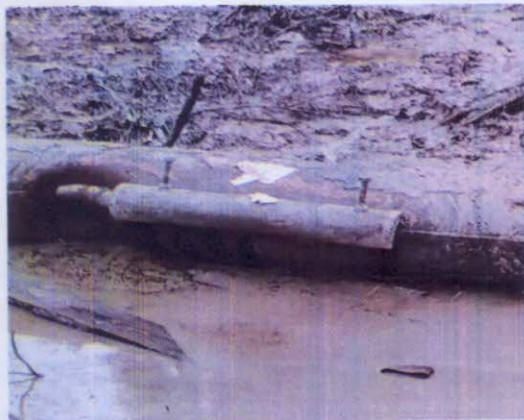
Fig B. SPILL POINT AFTER REPAIR

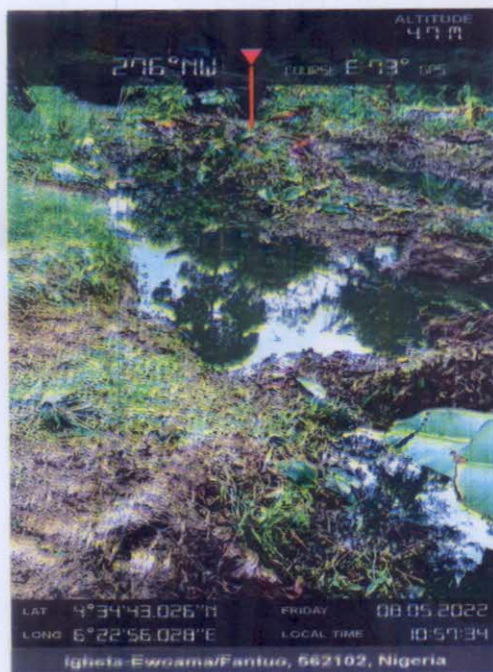
Fig C. SPILL IMPACTED AREA

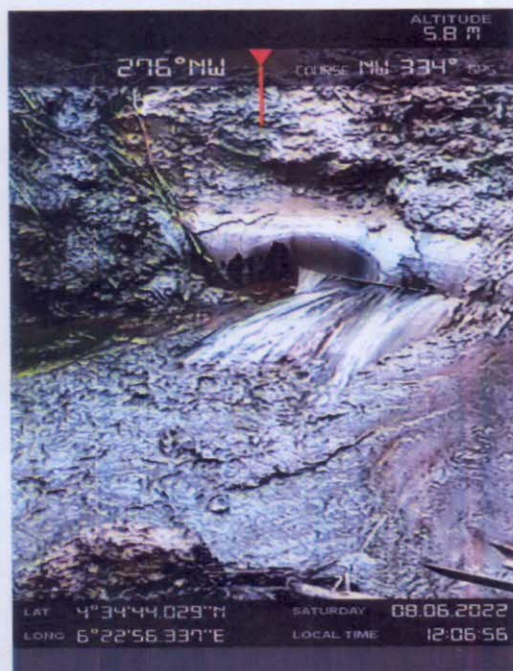
Fig D. SPILL POINT DURING EXCAVATION
