## APPENDIX I

### SOME PHOTOGRAPHS TAKEN DURING THE JOINT INVESTIGATION VISIT (JIV)

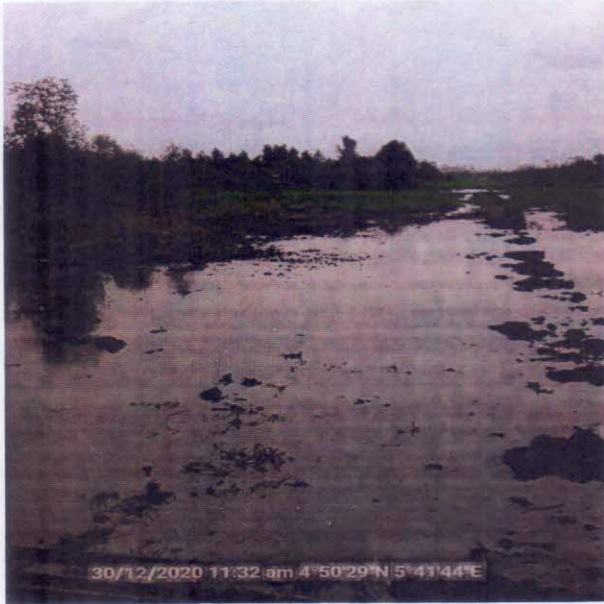
Fig A: Incident Area on arrival of JIT

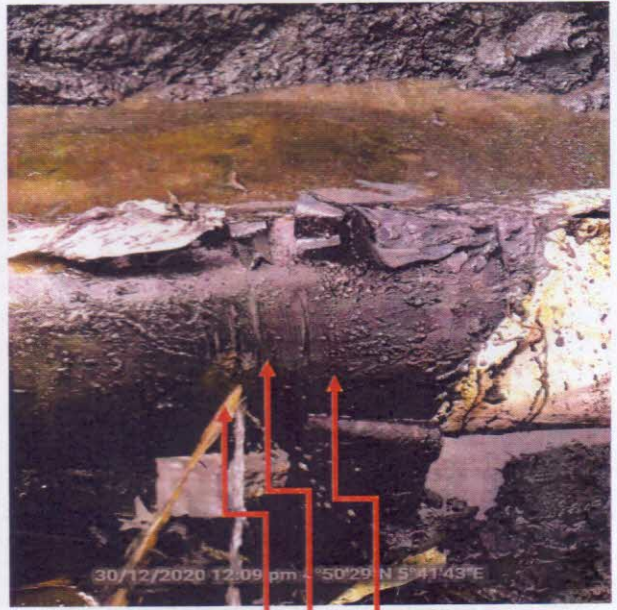
Fig B: Incident Facility shortly after excavation

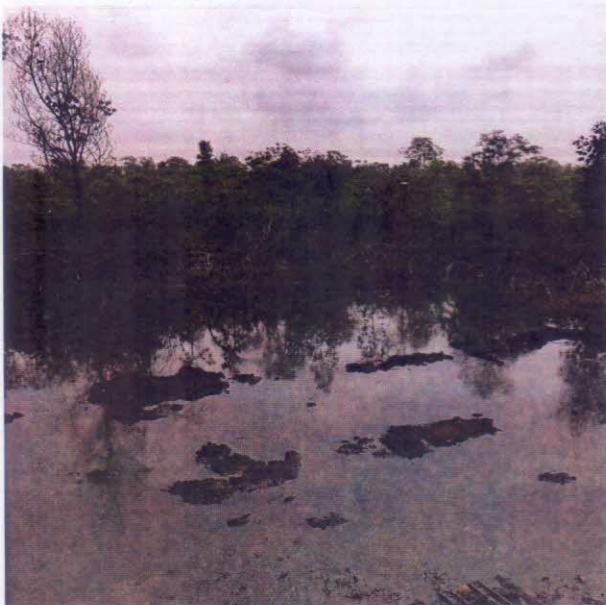
Fig C: Crude oil impact on the environment
