## PHOTOGRAPHS TAKEN DURING THE JOINT INVESTIGATION VISIT

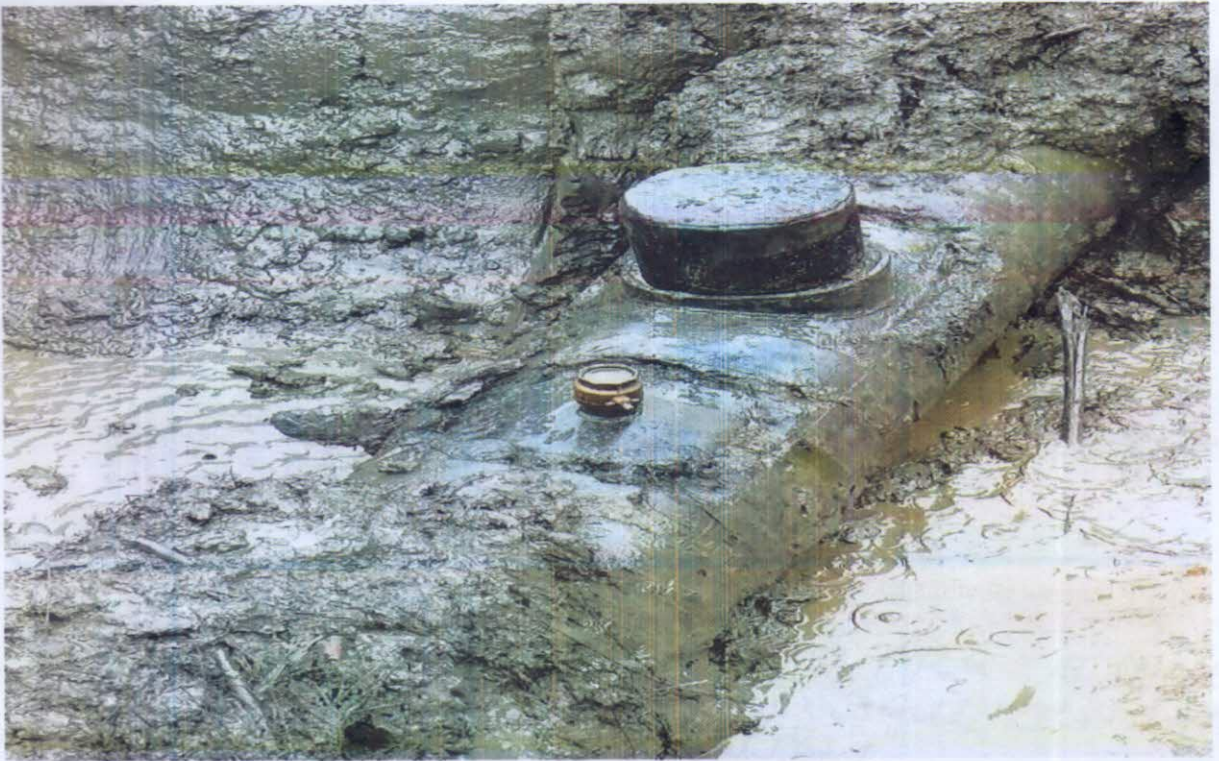
PICTURE SHOWING AFTER EXCAVATION OF THE SPILLED POINT, 2" VALVE INSTALLED FOR CRUDE OIL THEFT ACTIVITIES.
