## APPENDIX A

### PHOTOGRAPHS TAKEN DURING INSPECTION VISIT

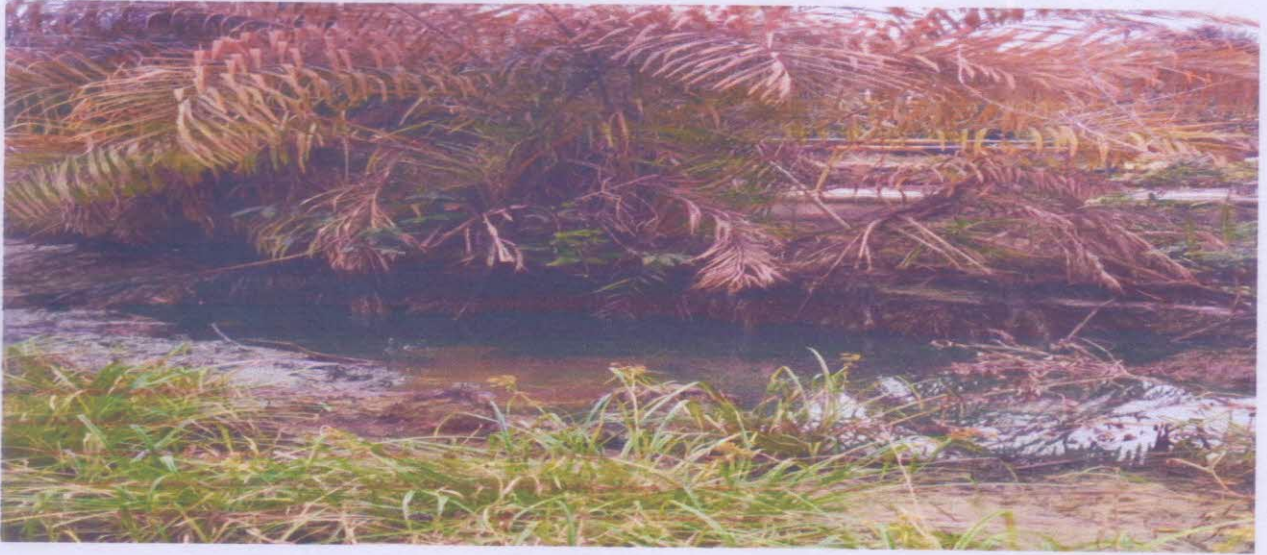
**SPILL POINT BEFORE EXCAVATION**

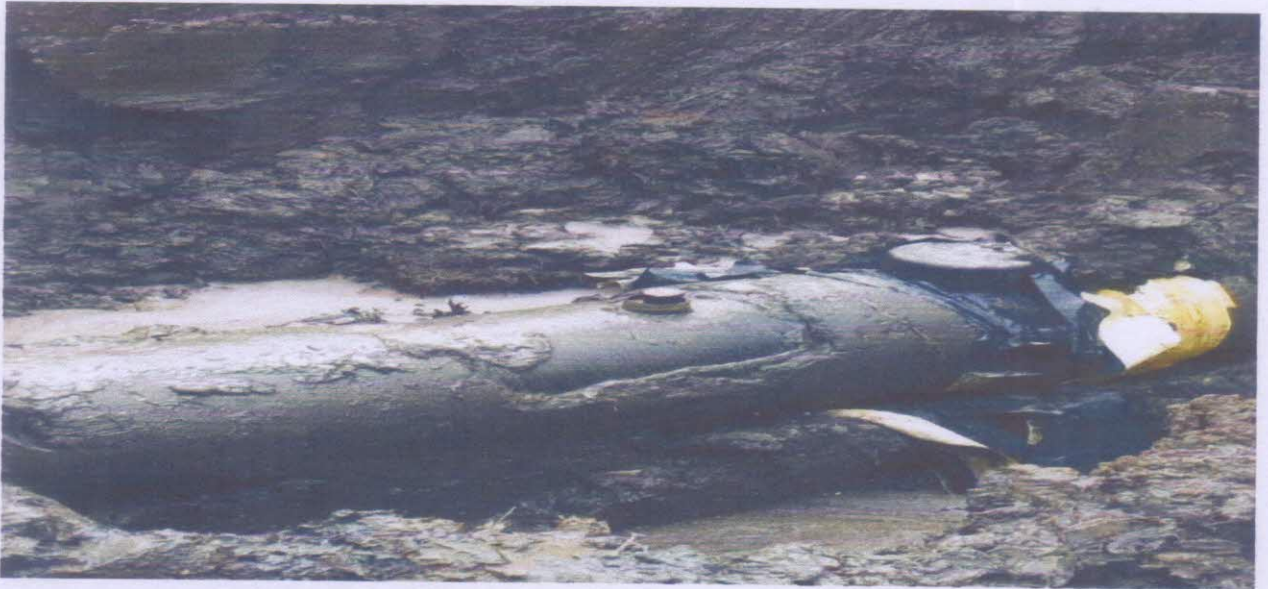
**SPILL POINT AFTER EXCAVATION SHOWN**
