## APPENDIX A

### PHOTOGRAPHS TAKEN DURING INSPECTION VISIT

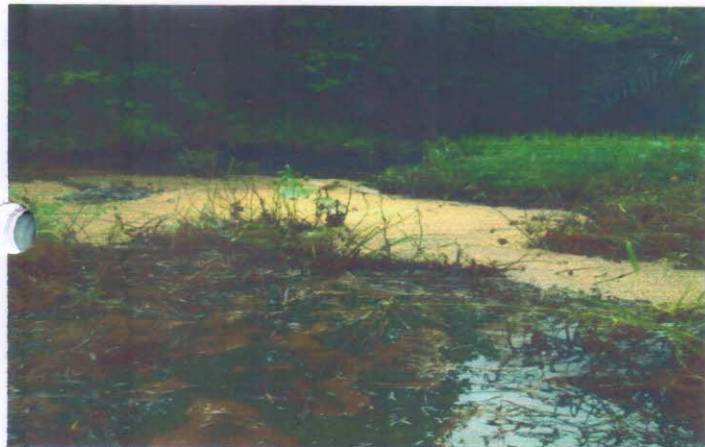
**SPILL POINT BEFORE EXCAVATION**

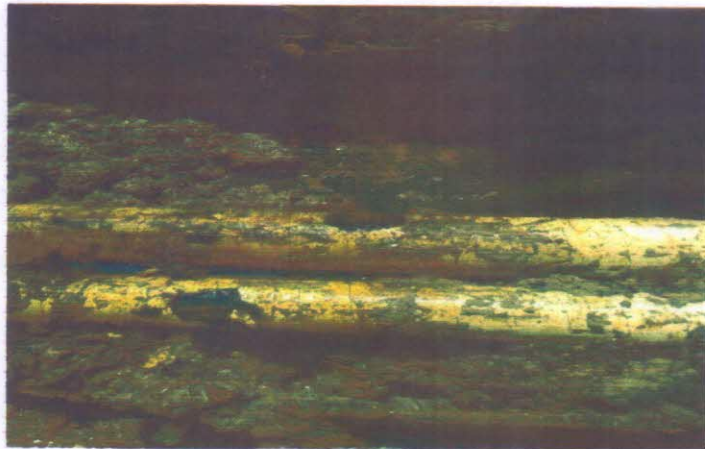
**SPILL POINT AFTER EXCAVATION**

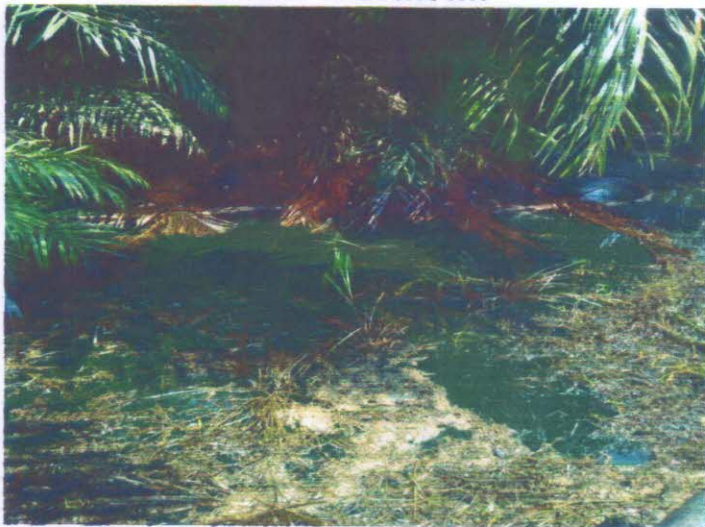
**IMPACTED AREA SHOWN**
