## APPENDIX A

### PHOTOGRAPHS TAKEN DURING INSPECTION VISIT

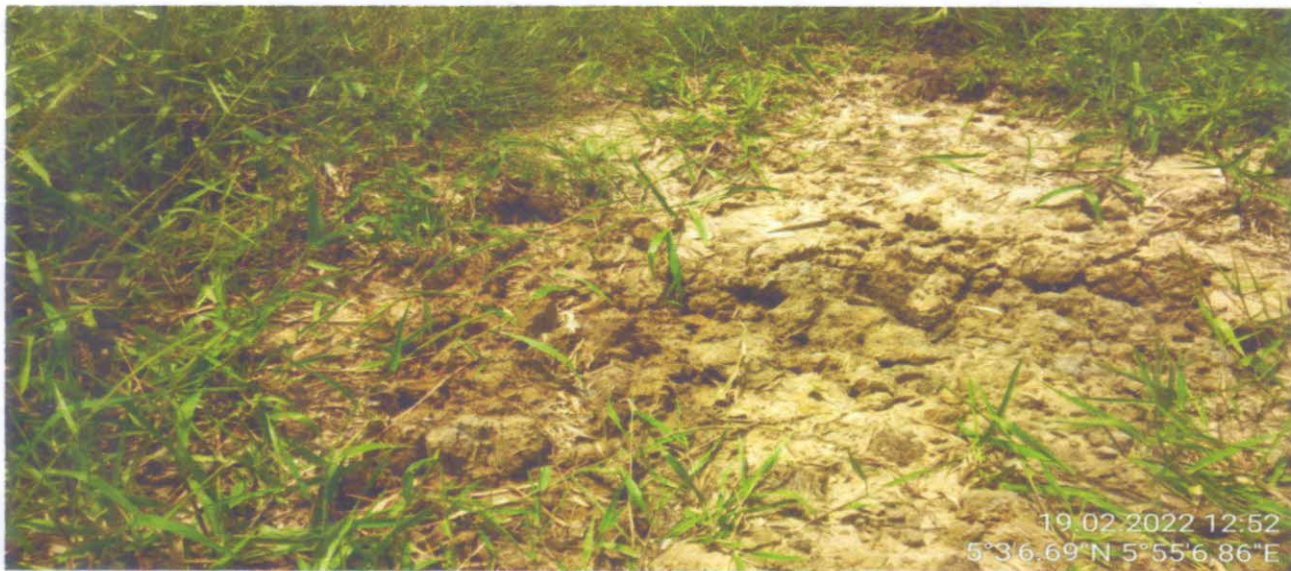
#### SPILL POINT BEFORE EXCAVATION

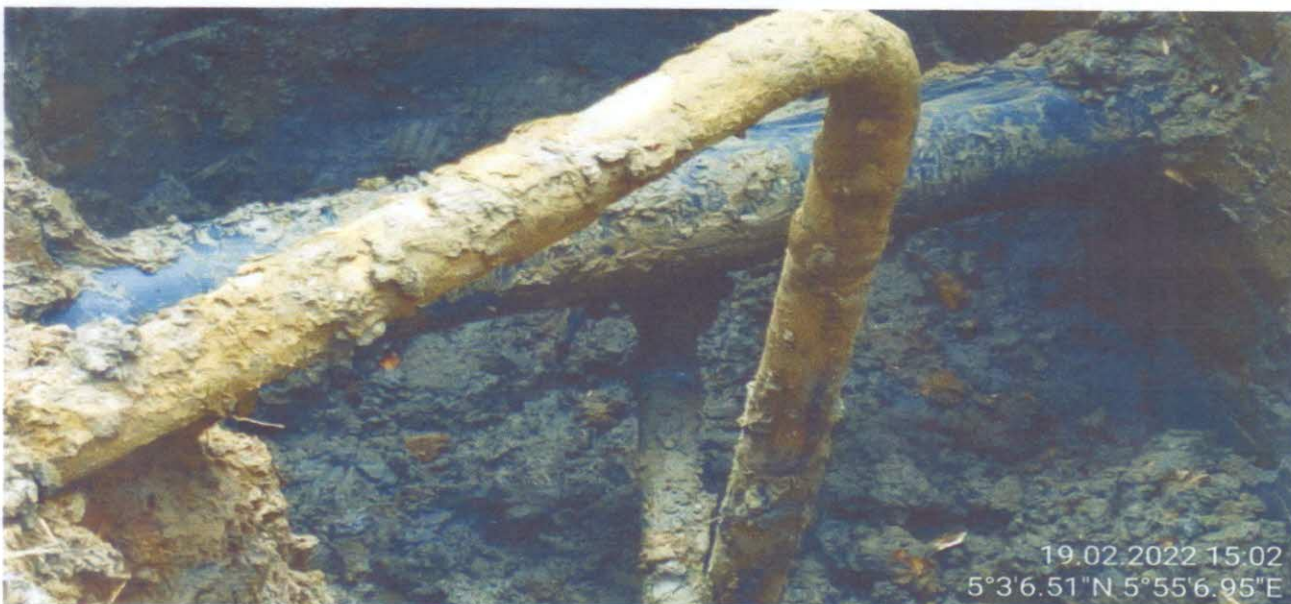
#### SPILL POINT AFTER EXCAVATION
