## APPENDIX A

PHOTOGRAPHS TAKEN DURING A JOINT INVESTIGATION VISIT TO  
24" OBAMA/TEBIDABA/BRASS PIPELINE AT  
FANTUO/OKPOMA/EWOMA, NEMBE LOCAL GOVERNMENT AREA,  
BAYELSA STATE.

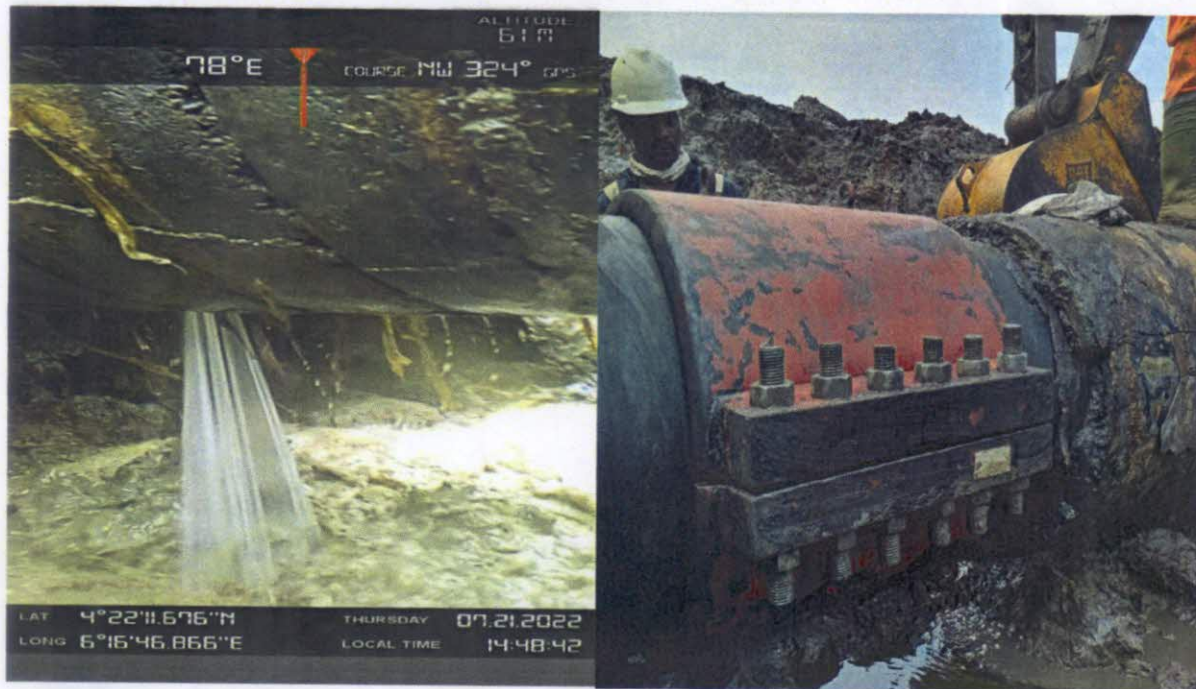
PICTURE A: CORROSION AT 6 O' CLOCK POSITION. PICTURE B: CLAMPED SECTION OF THE PIPELINE.
