## APPENDIX A

### PHOTOGRAPHS TAKEN DURING A JOINT INVESTIGATION VISIT TO 14" OGBOINBIRI-TEBIDABA PIPELINE AT OKPOTUWARI, SOUTHERN IJAW LOCAL GOVERNMENT AREA, BAYELSA STATE.

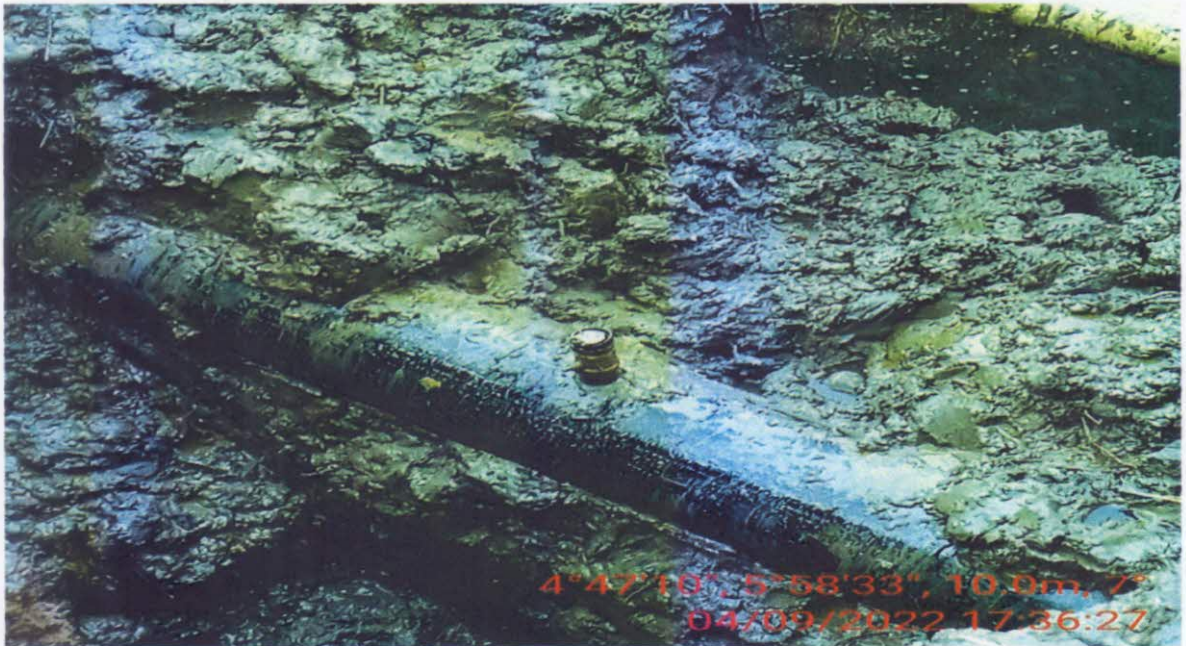
PICTURE 1: SHOWING 2" VALVE INSTALLED ON THE PIPELINE FOR OIL THEFT

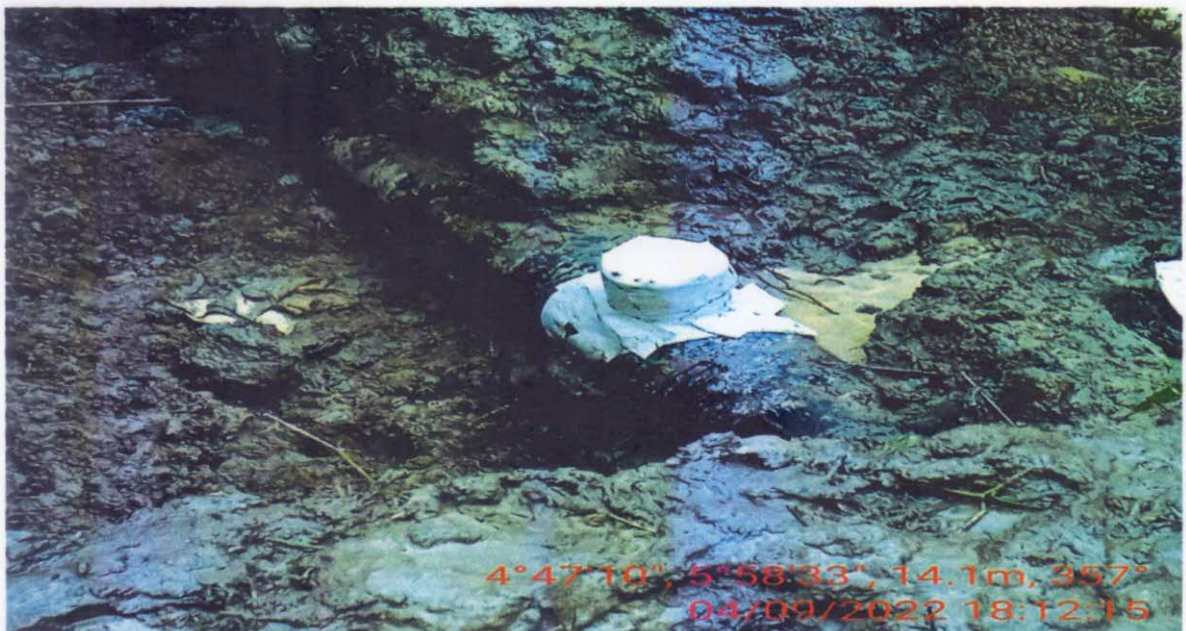
PICTURE 2: SHOWING THE INCIDENT POINT AFTER REPAIR
