**APPENDIX A**  
**PHOTOGRAPHS TAKEN DURING A JOINT INVESTIGATION VISIT TO**  
**18" TEBIDABA/BRASS PIPELINE AT KALATORU, SOUTHERN IJAW**  
**LOCAL GOVERNMENT AREA, BAYELSA STATE.**

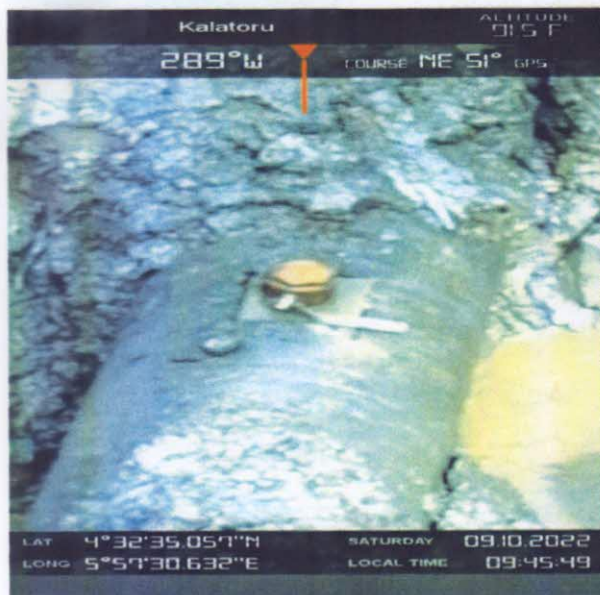
**PICTURE 1: SHOWING INSTALLED 3" VALVE AT POINT A.**

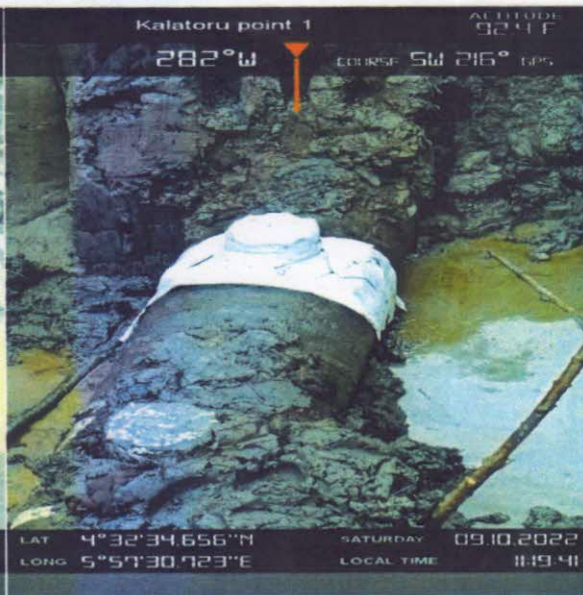
**PICTURE 2: SHOWING POINT A AFTER REPAIRS**

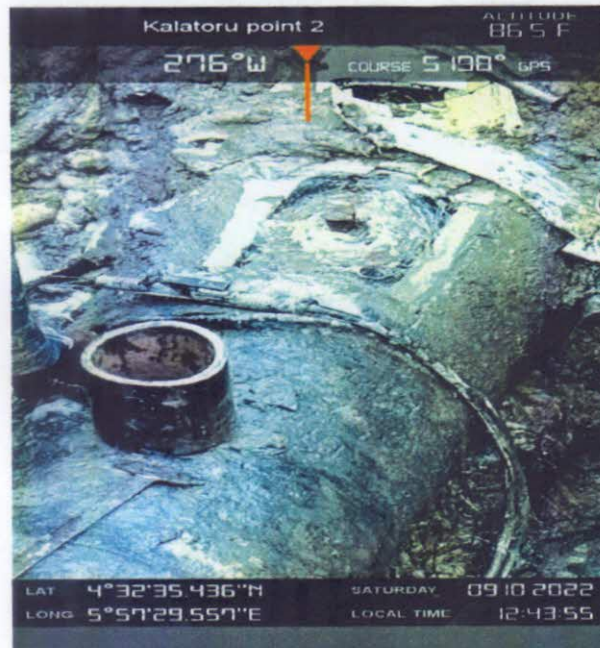
**PICTURE 3: SHOWING INCIDENT POINT B.**

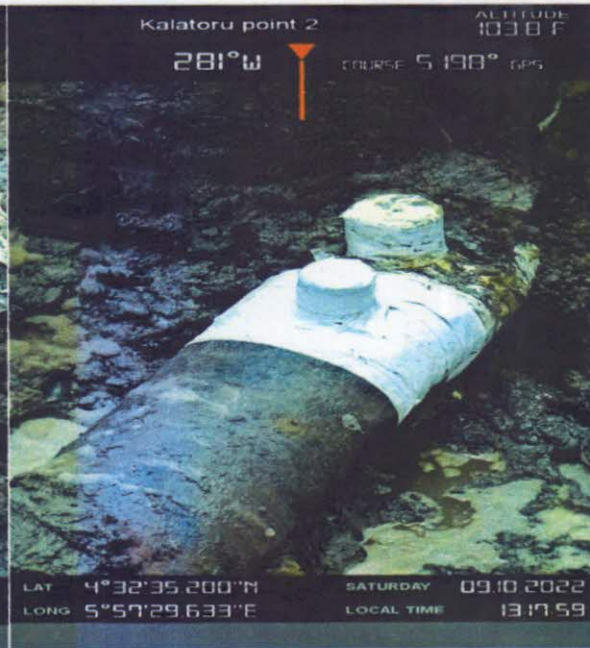
**PICTURE 4: SHOWING POINT B AFTER REPAIRS**
