**PHOTOGRAPHS TAKEN DURING JIV AT 18"TEBIDABA/BRASS PIPELINE AT MBIKIBA  
SOUTHERN IJAW LOCAL GOVERNMENT AREA, BAYELSA STATE.**

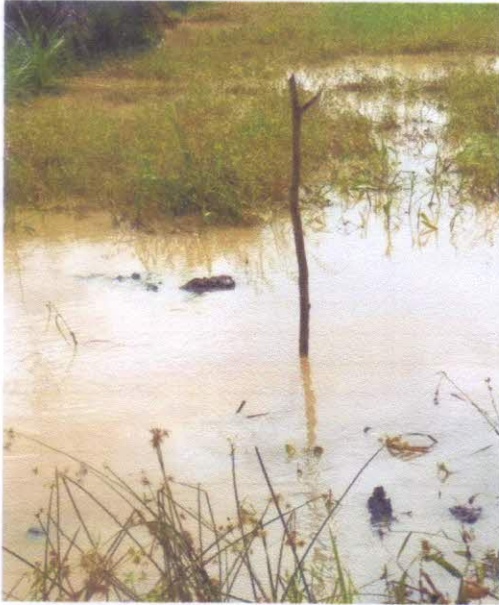
**FIG. 1 SHOWING SPILL POINT (BEFORE REPAIR)**

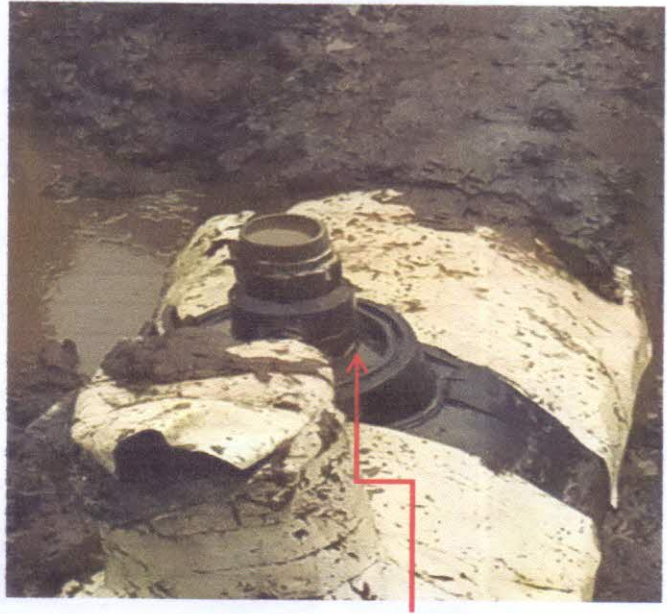
**FIG.2 Incident facility after exposure 6" inch valve**
