**PHOTOGRAPHS TAKEN DURING JIV AT 18"TEBIDABA/BRASS PIPELINE AT MBIKIBA  
SOUTHERN IJAW LOCAL GOVERNMENT AREA, BAYELSA STATE.**

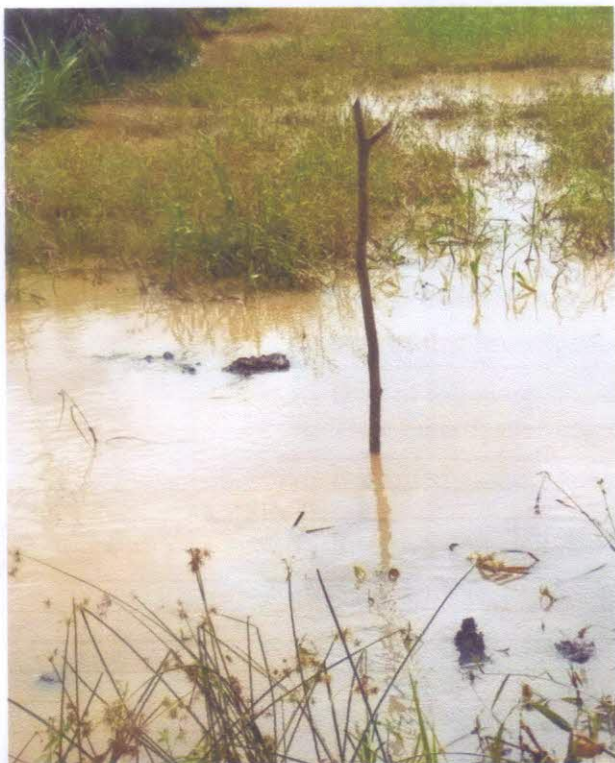
**FIG. 1 Incident Area on arrival of the JIT**

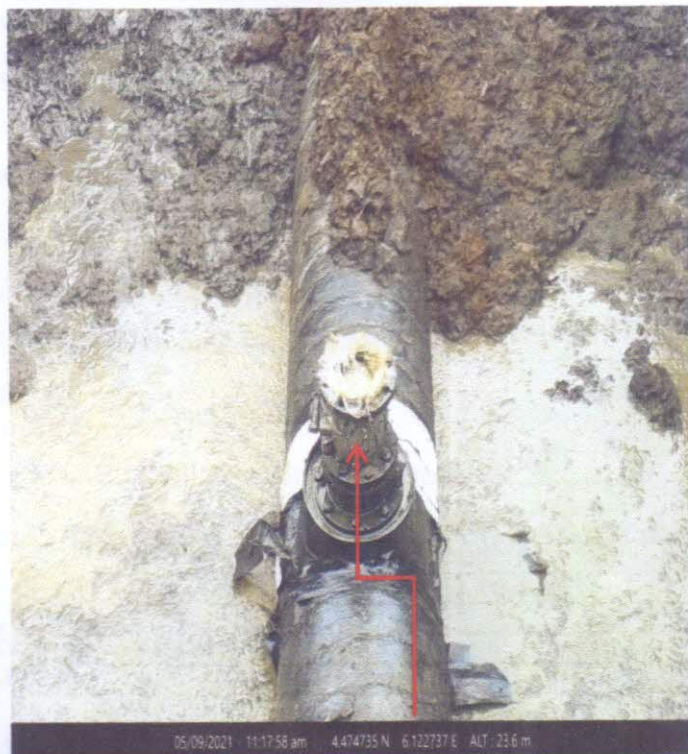
**FIG.2 Incident facility after exposure 6" inch valve**

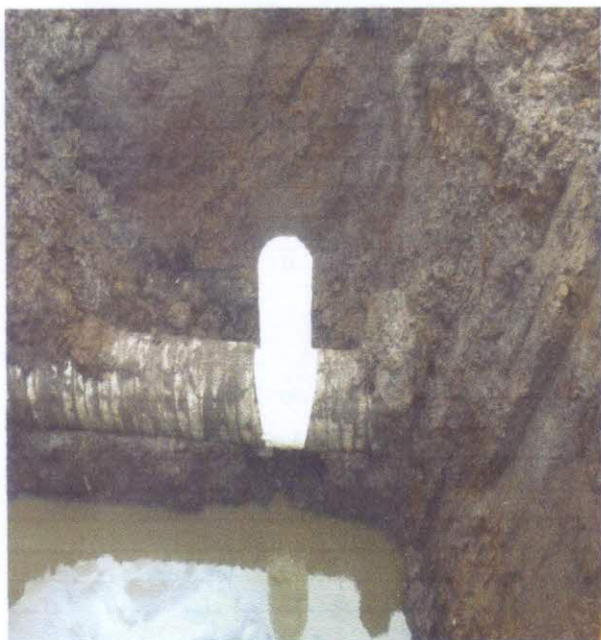
**FIG.3 SHOWING SPILL POINT (AFTER REPAIR)**

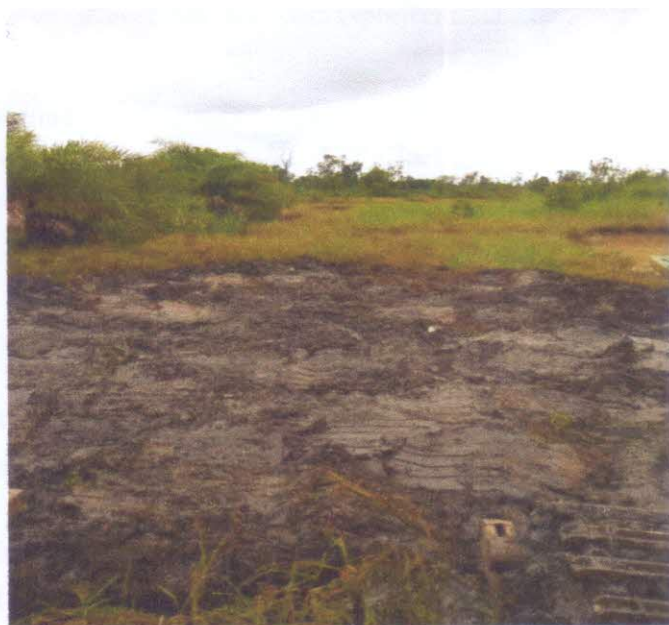
**FIG. 4SHOWING BACKFILL**
