**APPENDIX A**  
**PHOTOGRAPHS TAKEN DURING JIV AT 18"TEBIDABA/BRASS PIPELINE AT**  
**MBIKIBA SOUTHERN IJAW LOCAL GOVERNMENT AREA, BAYELSA STATE.**

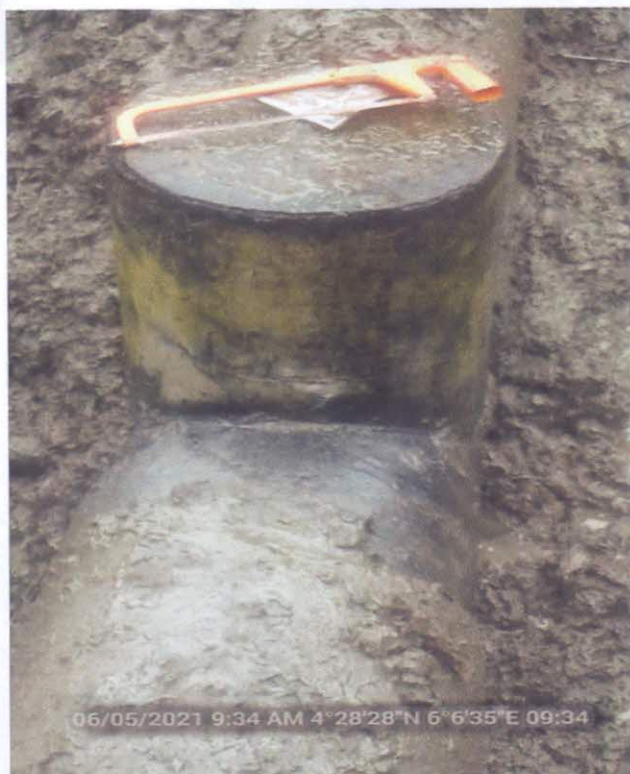
**FIG. 1 SHOWING SPILL POINT (BEFORE REPAIR)**

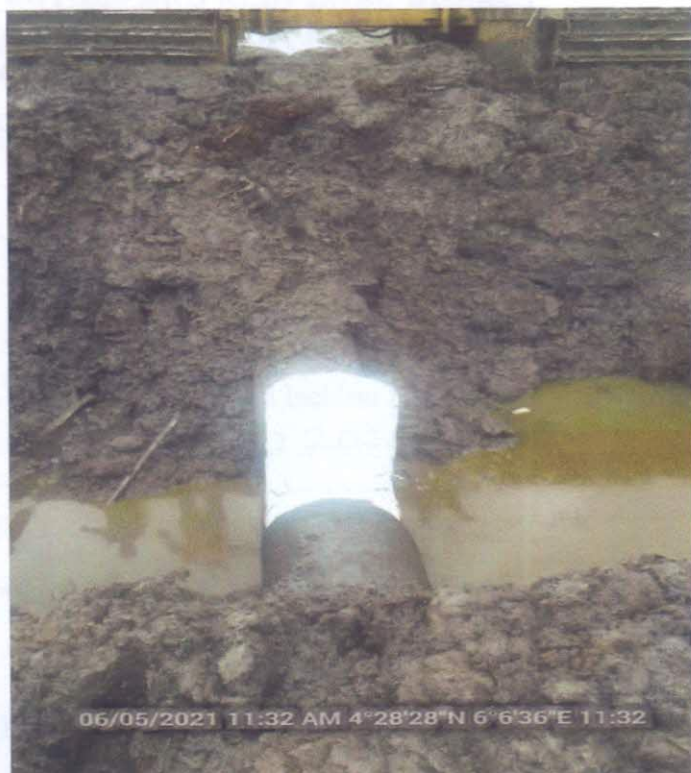
**FIG.2 SHOWING SPILL POINT (AFTER REPAIR)**

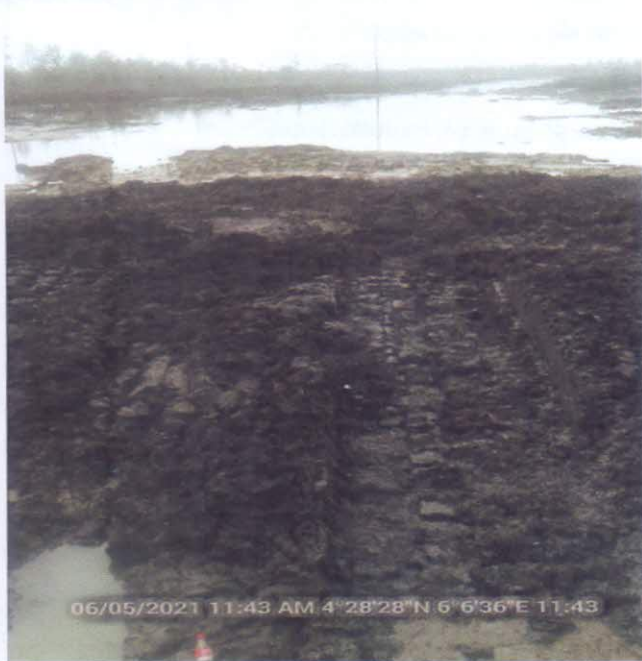
**FIG.3 SHOWING BACKFILL**
