## APPENDIX I

### SOME PHOTOGRAPHS TAKEN DURING THE JOINT INVESTIGATION VISIT

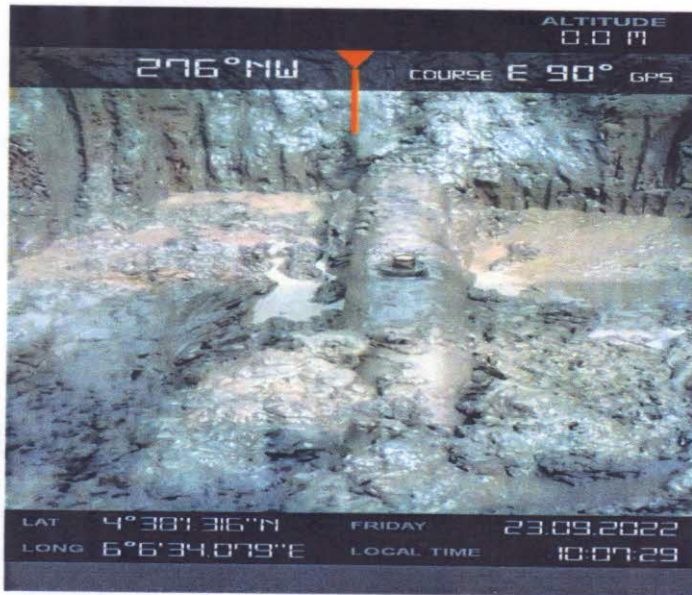
FIG 1: Incident Point/Facility

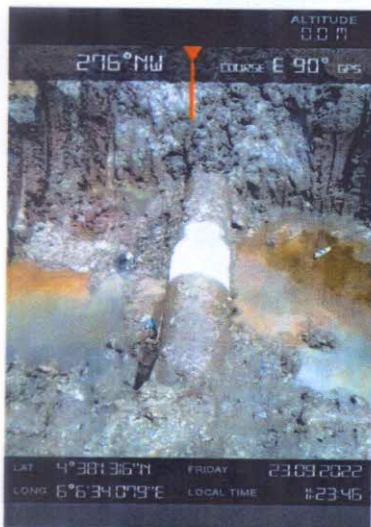
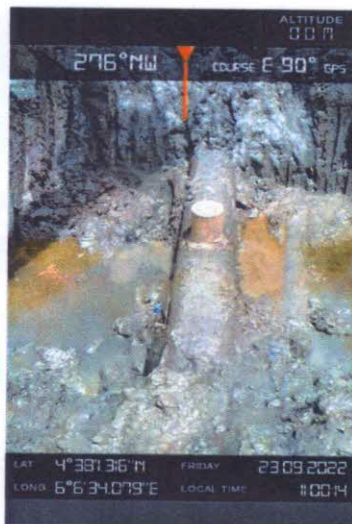
FIG 2-3: Incident Facility repaired and Aqua wrapped

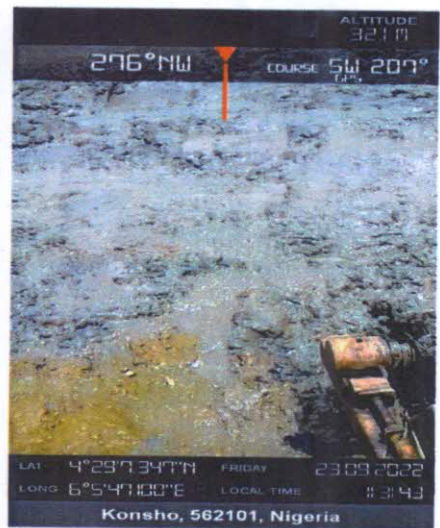
FIG 4: Backfilled Incident Point
