# APPENDIX I

## SOME PHOTOGRAPHS TAKEN DURING THE JOINT INVESTIGATION VISIT

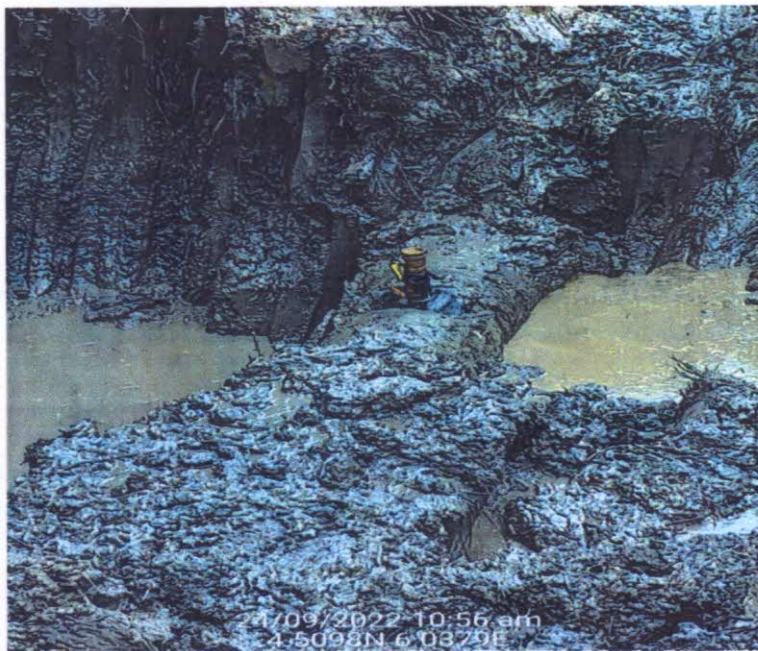
**FIG 1: Installed 2 1/2" valve on the facility**

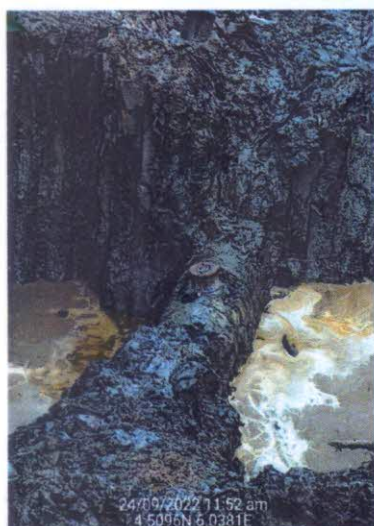
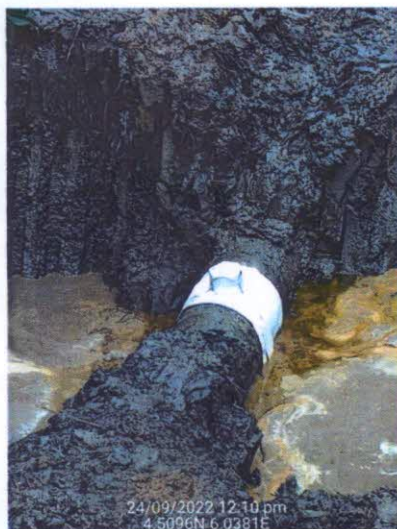
**FIG 2-3: Incident Facility repaired and Aqua wrapped**

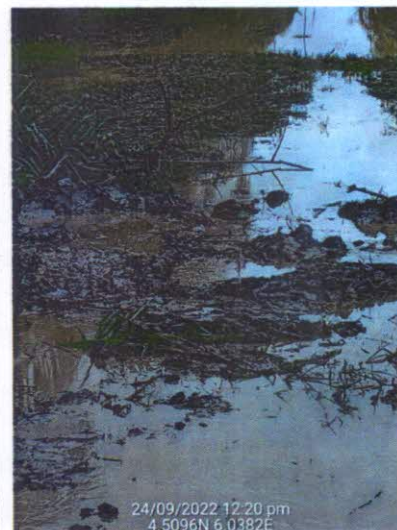
**FIG 4: Backfilled Incident Point**
