## APPENDIX I

### SOME PHOTOGRAPHS TAKEN DURING THE JOINT INVESTIGATION VISIT

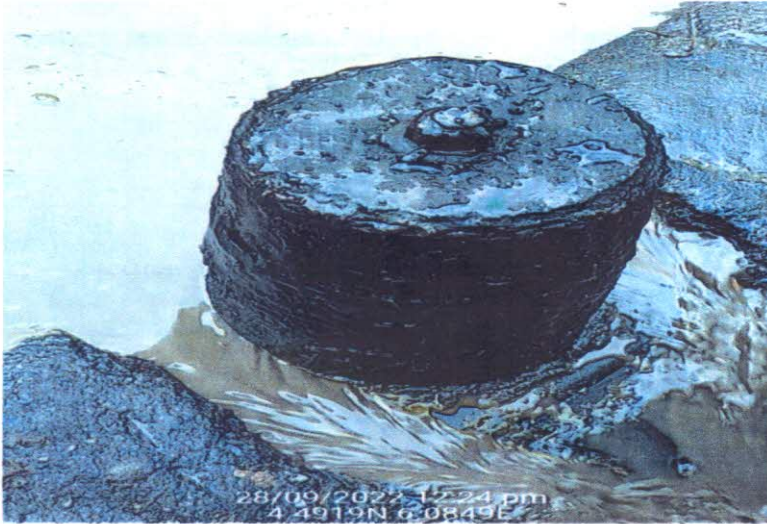
**FIG 1: Incident facility**
