# APPENDIX I

## SOME PHOTOGRAPHS TAKEN DURING THE JOINT INVESTIGATION VISIT

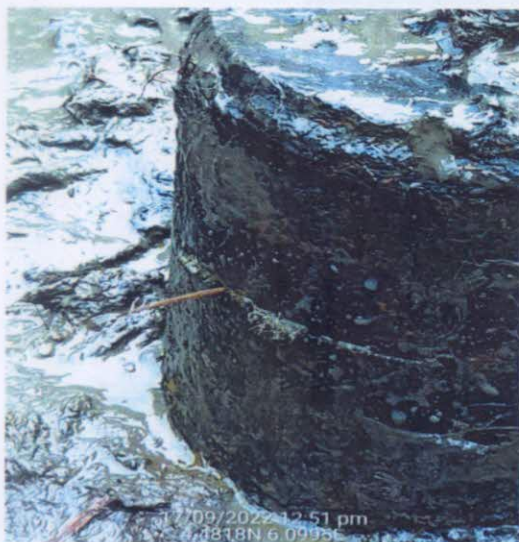
**FIG 1: Incident Point/Facility**

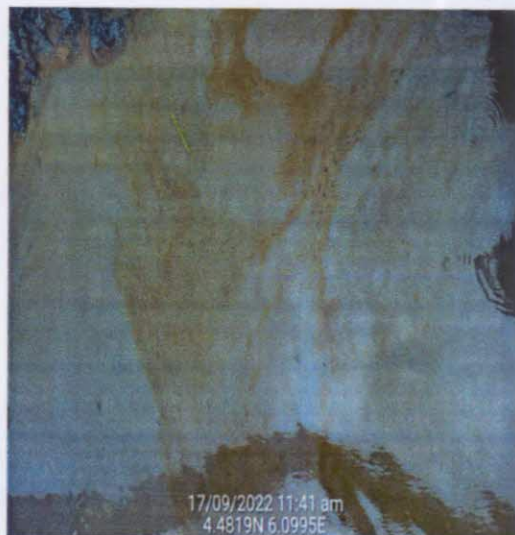
**FIG 2: Spilled Oil**
