## APPENDIX A:

PHOTOGRAPHS TAKEN DURING JIV AT 6" OGBOINBIRI/TEBIDABA PIPELINE AT IKEBIRI IN SOUTHERN IJAW LOCAL GOVERNMENT AREA OF BAYELSA STATE

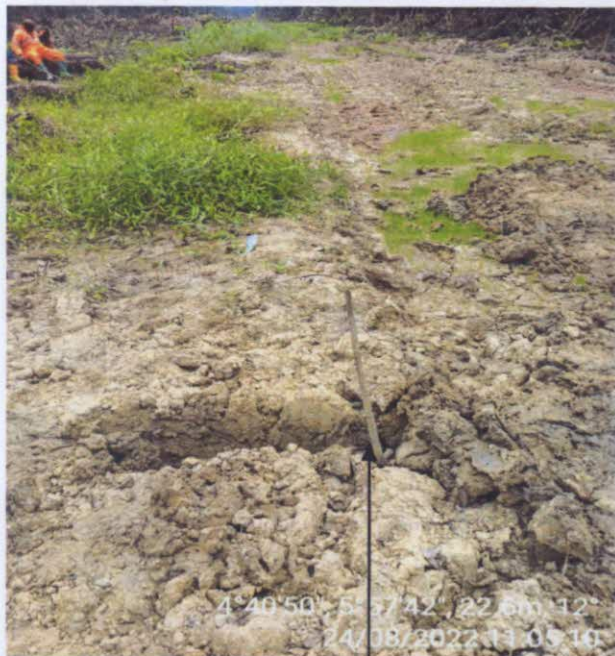
**SPILL POINT BEFORE EXCAVATION**

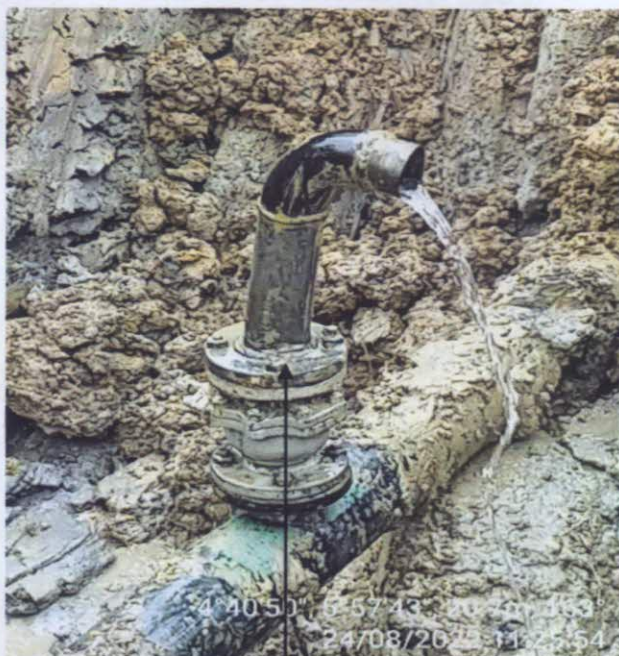
**SPILL POINT**

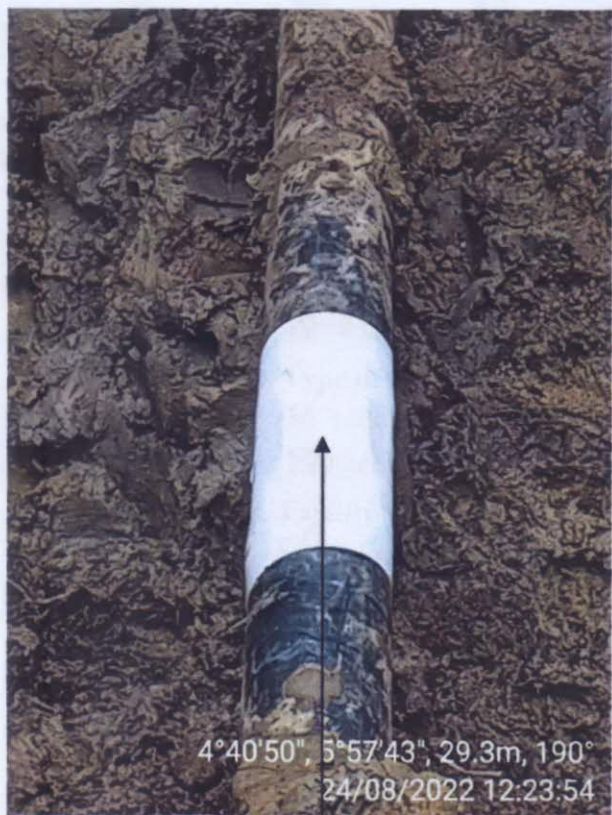
**REPAIR POINT**

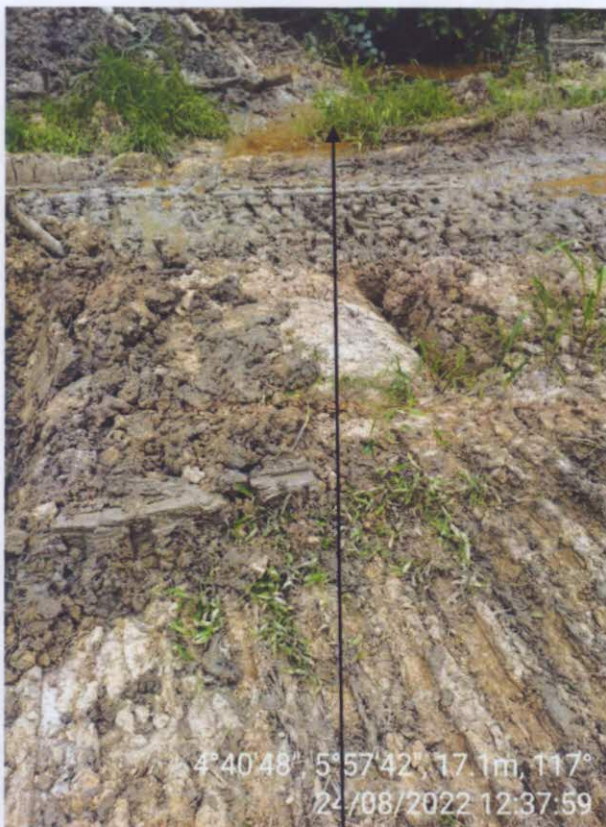
**IMPACTED AREA**
