## APPENDIX A:

PHOTOGRAPHS TAKEN DURING JIV AT 14" OGBOINBIRI/TEBIDABA PIPELINE AT IKEBIRI IN SOUTHERN IJAW LOCAL GOVERNMENT AREA OF BAYELSA STATE

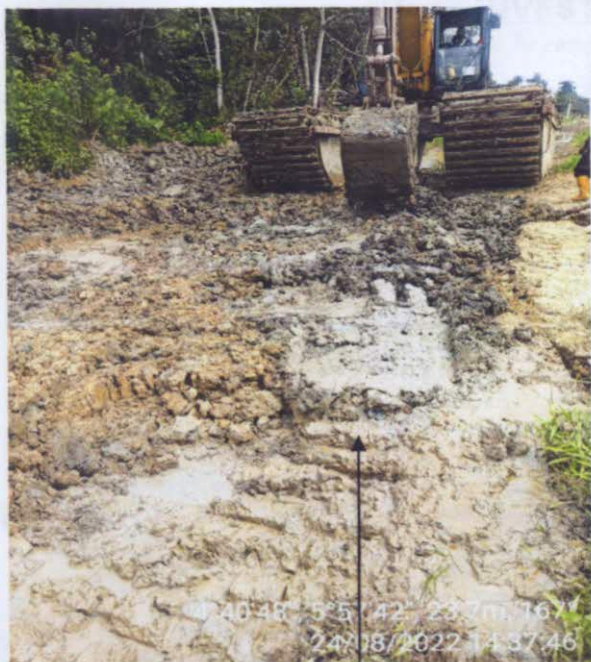
**SPILL POINT BEFORE EXCAVATION**

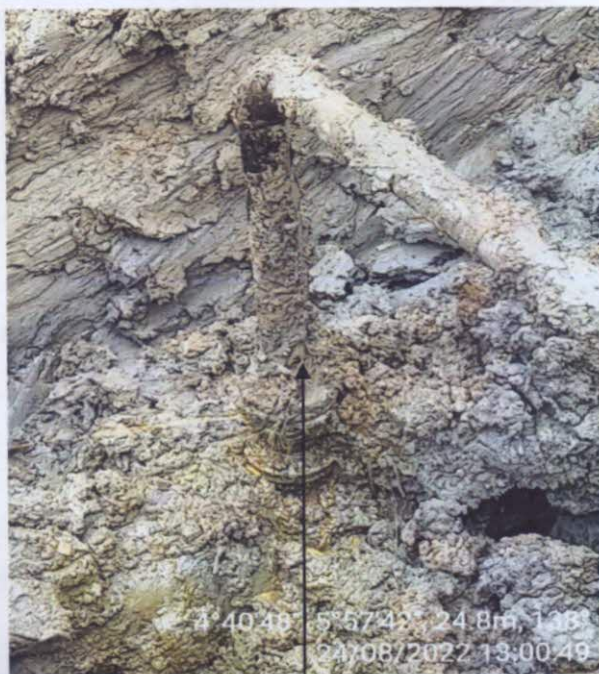
**SPILL POINT**

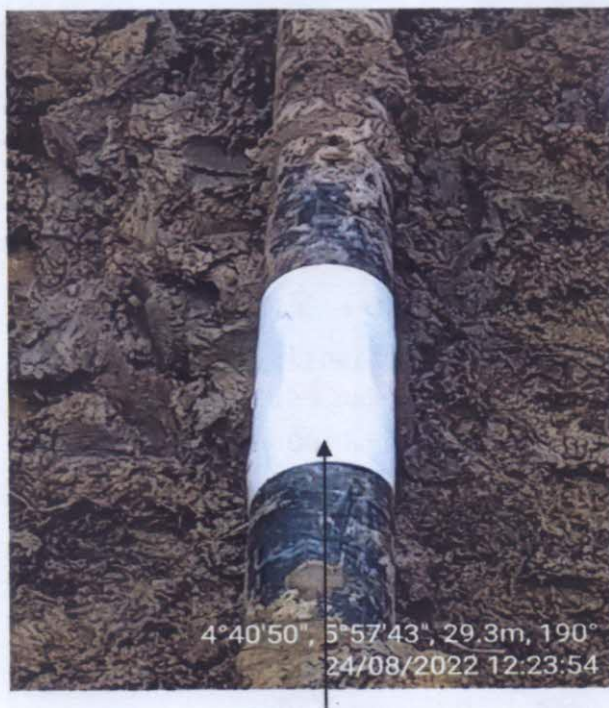
**REPAIR POINT**

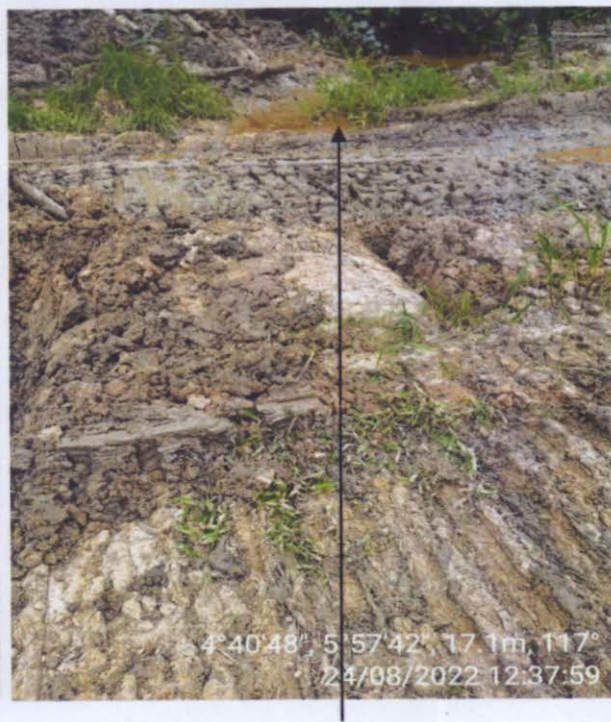
**IMPACTED AREA**
