**APPENDIX A:**

*PHOTOGRAPHS TAKEN DURING JIV AT 6" OGBOINBIRI/TEBIDABA PIPELIE AT OKPOTUWARI  
IN SOUTHERN IJAW LOCAL GOVERNMENT AREA OF BAYELSA STATE*

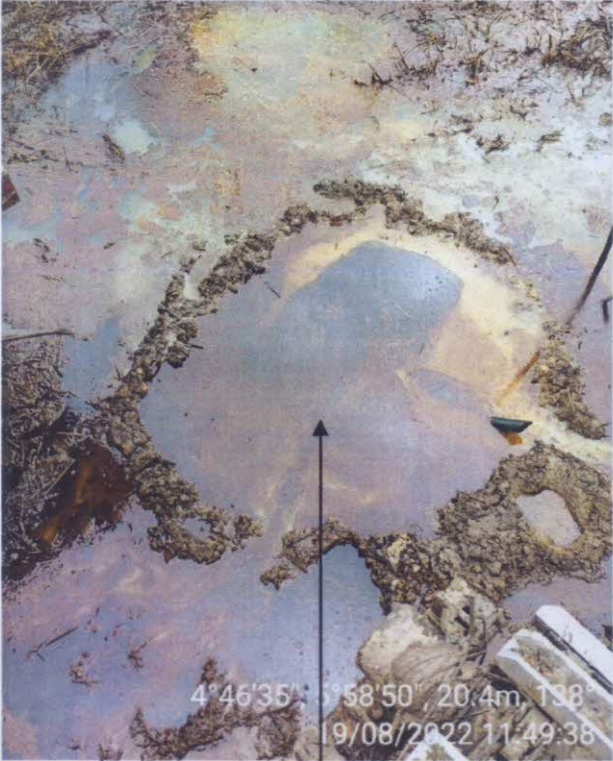
**SPILL POINT BEFORE EXCAVATION**

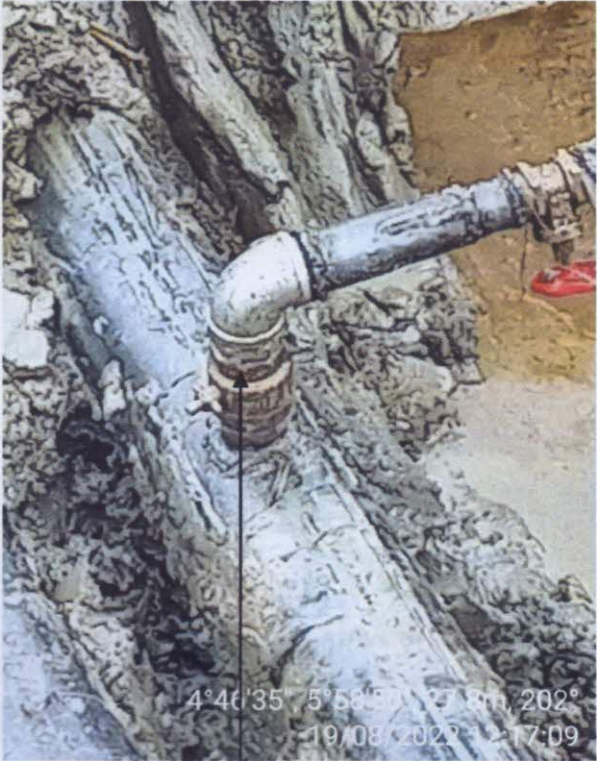
**SPILL POINT**

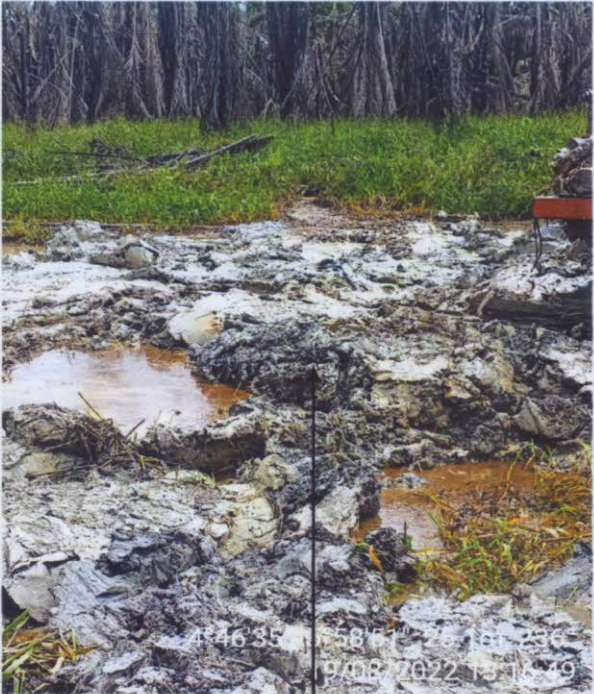
**IMPACTED AREA**
