## APPENDIX A:

PHOTOGRAPHS TAKEN DURING JIV AT 14" OGBOINBIRI/TEBIDABA PIPELINE AT KEME-EBIAMA  
IN SOUTHERN IJAW LOCAL GOVERNMENT AREA OF BAYELSA STATE

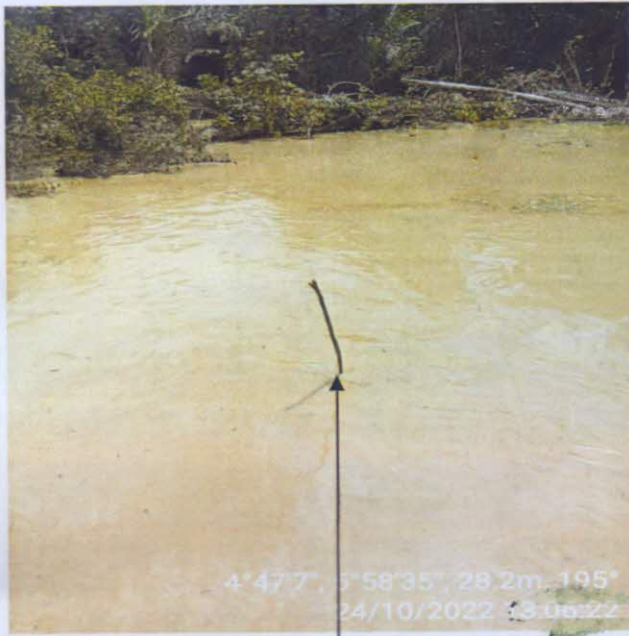
SPILL POINT BEFORE EXCAVATION

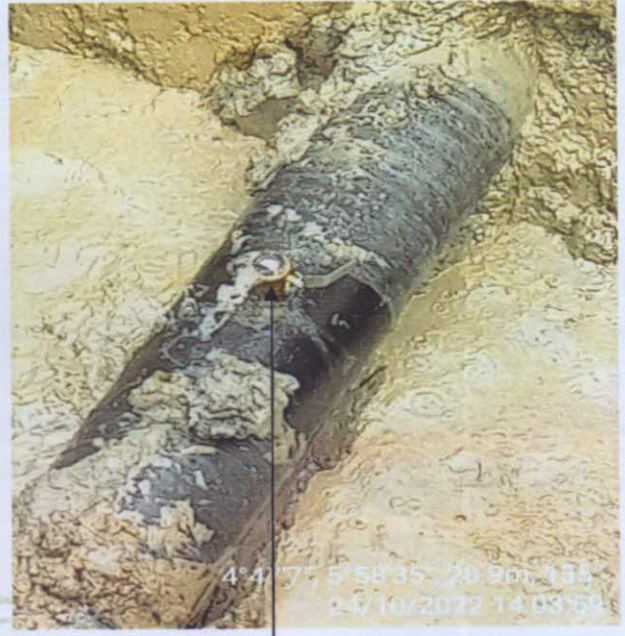
SPILL POINT (INSTALLED 2" VALVE)

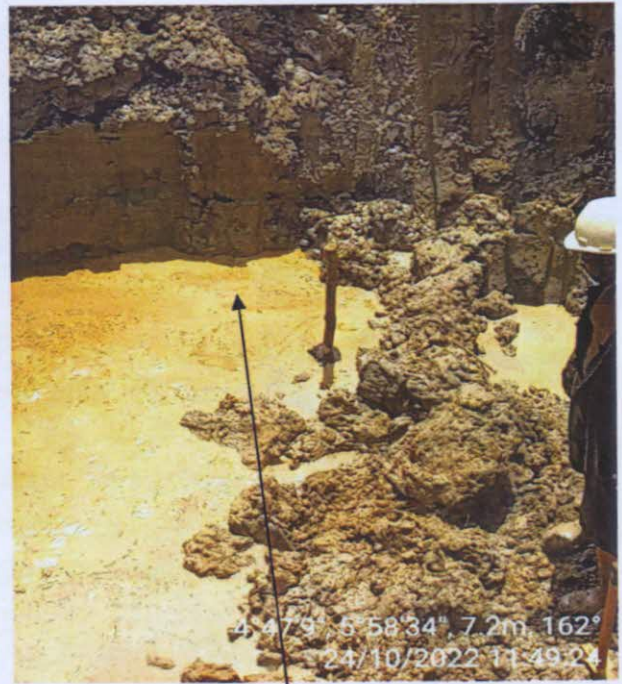
IMPACTED AREA
