## APPENDIX A

PICTURES TAKEN DURING THE JOINT INVESTIGATION VISIT AT 18" TEBIDABA/BRASS PIPELINE AT LAGOSGBENE, SOUTHERN IJAW LOCAL GOVERNMENT, BAYELSA STATE.

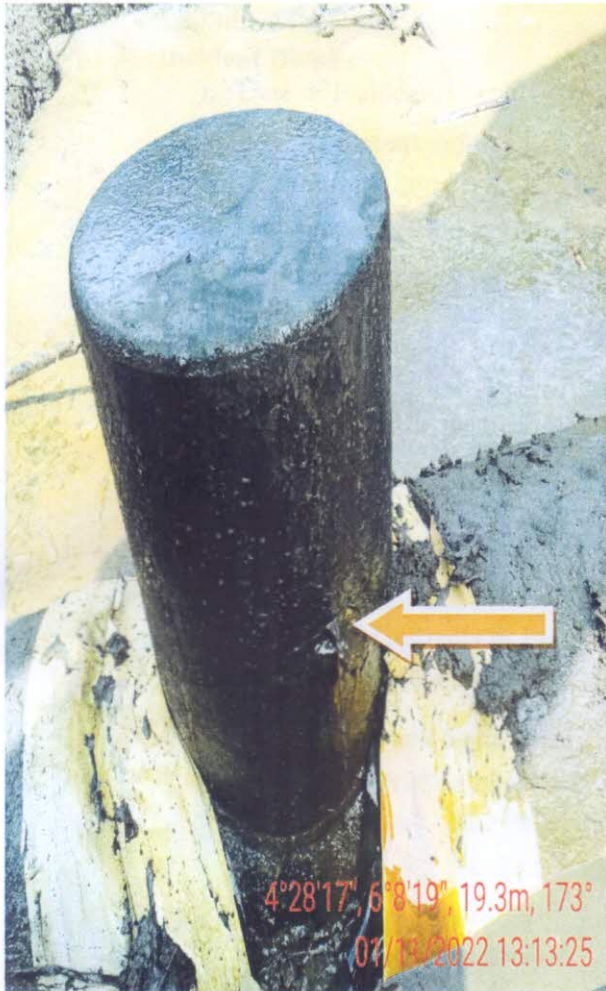
PICTURE 1 FROM LEFT: SHOWING A 15 MM INCISION MADE WITH HACKSAW BY VANDALS ON A PREVIOUSLY CONED INCIDENT POINT.
